Adhunik Poshak Shilpa Ltd.

Avenue-1, Industrial plot-1, Block-E, Section-11, Mirpur, Dhaka.

25 June 2014

Observations

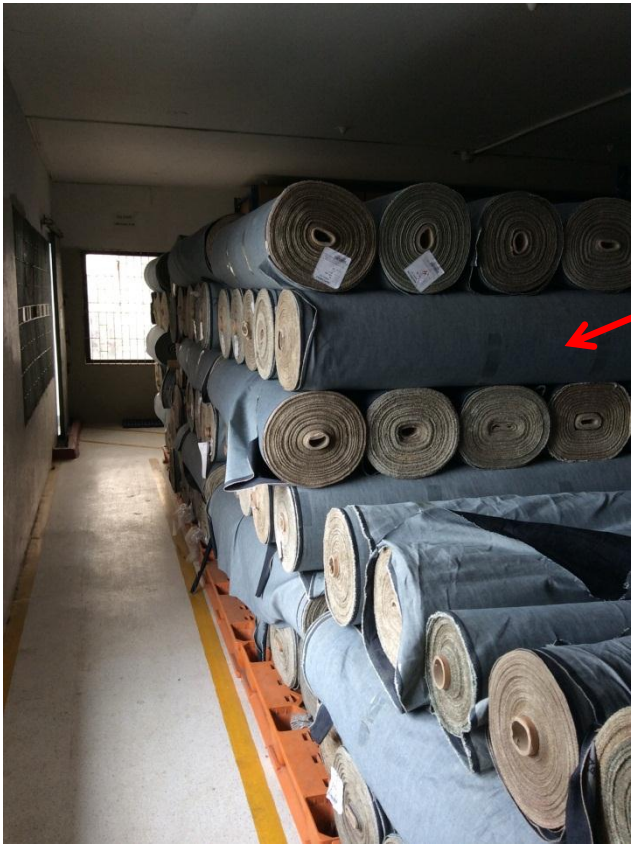
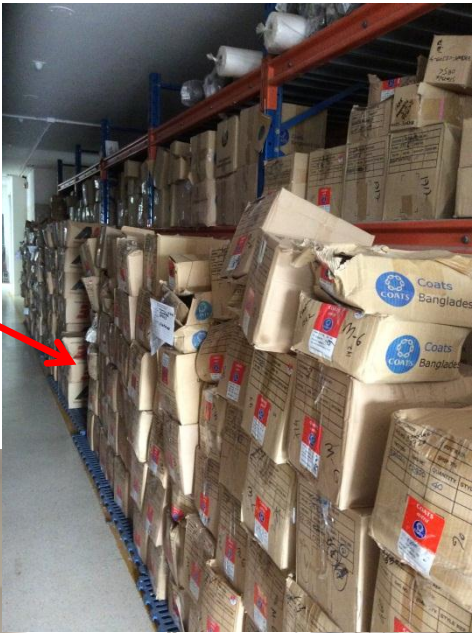
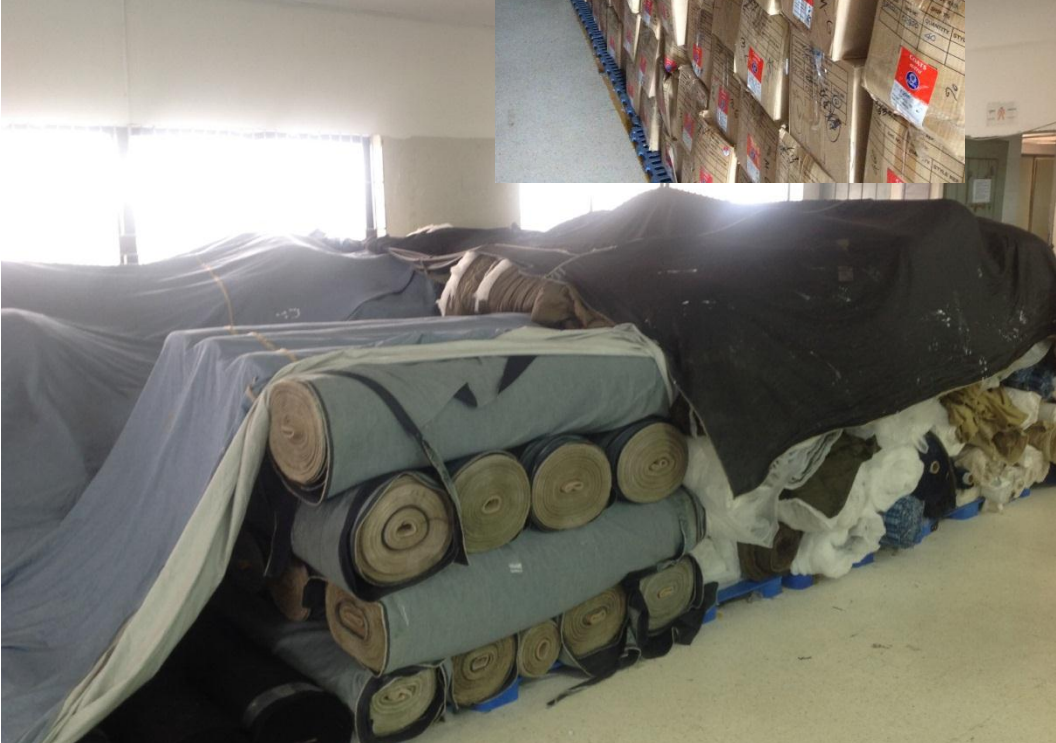
Areas of high loading observed

High storage loads on level 5 and 3

Heavy storage observed on several floors. Punching shear of the flat slab is a concern

Rolls of fabric stored on production/sewing floors

Item No.	Observation	Recommended Action Plan	Recommended Timeline
1	Areas of high loading observed	Produce and actively manage a loading plan for all floor plates within the factory giving consideration to floor slab and column capacity	6-months
2	Relatively high working stress in columns supporting water tanks and toilet blocks	Building engineer to review design, load and column stresses in the area identified above.	6-months
3	Relatively high working stress in columns supporting water tanks and toilet blocks	Verify insitu concrete stresses by existing cylinder strength for the identified columns above or 100mm dia. cores from 4 columns.	6-months
4	Relatively high working stress in columns supporting water tanks and toilet blocks	Produce and actively manage a loading plan for all floor plates within the factory giving consideration to floor capacity and column capacity	6-months
5	Inconstancies between documentation and as built construction	Building engineer to check, collect information and produce accurate and complete as-built documentation	6-months

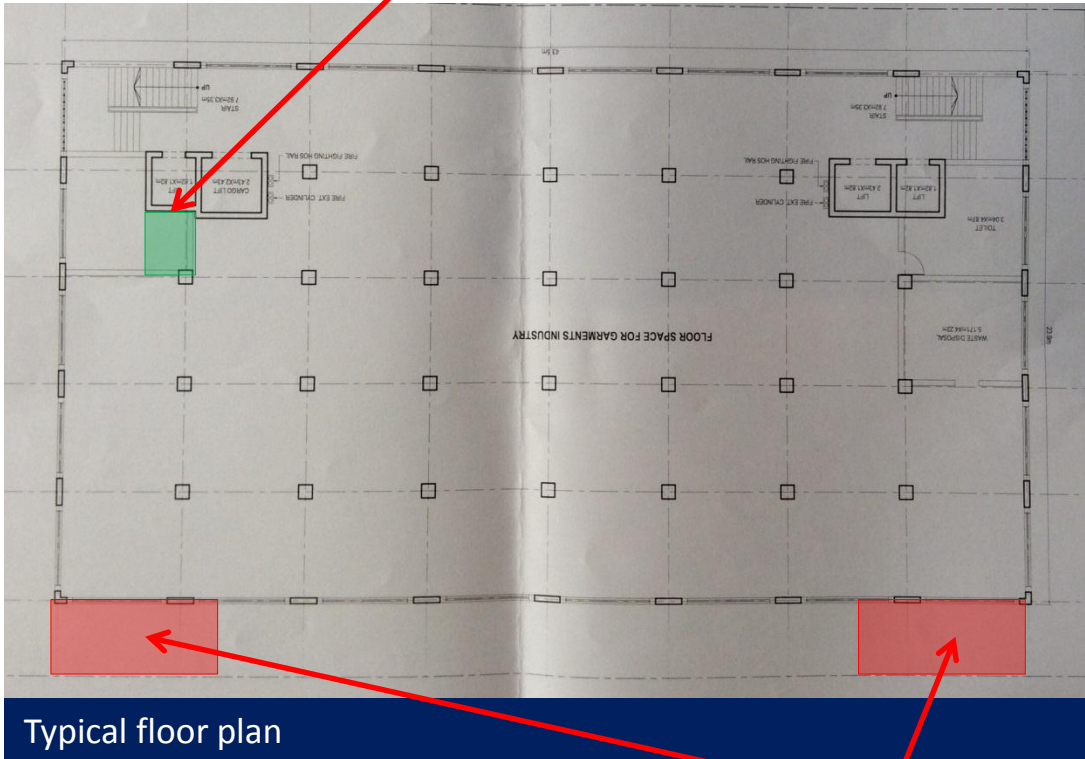
Inconstancies between documentation and as built construction

An additional lift shaft was provided in the western shear core which was not observed on the structural drawings.

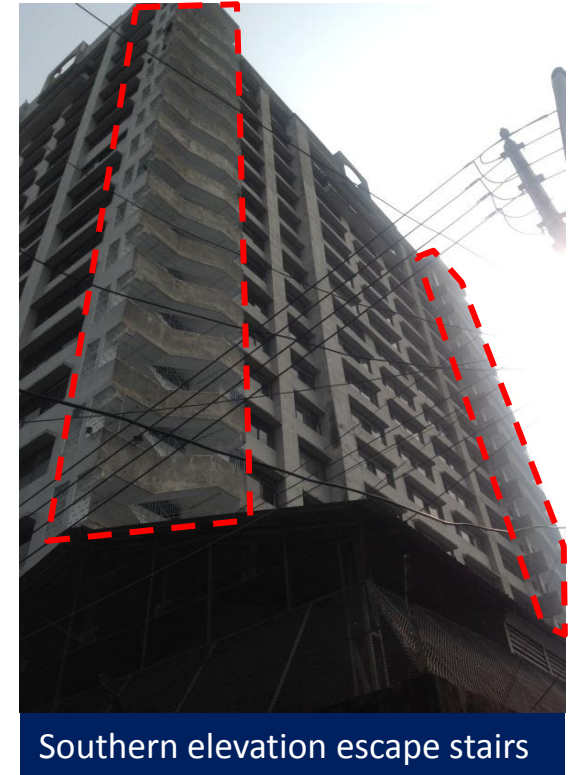
Two additional escape stair cases were provided to the building on the southern elevation. These stairs had their own supporting columns which were not observed on the floor plans.
