# 5F Apparels Ltd

28<sup>th</sup> January 2015

# Non Structural Observation

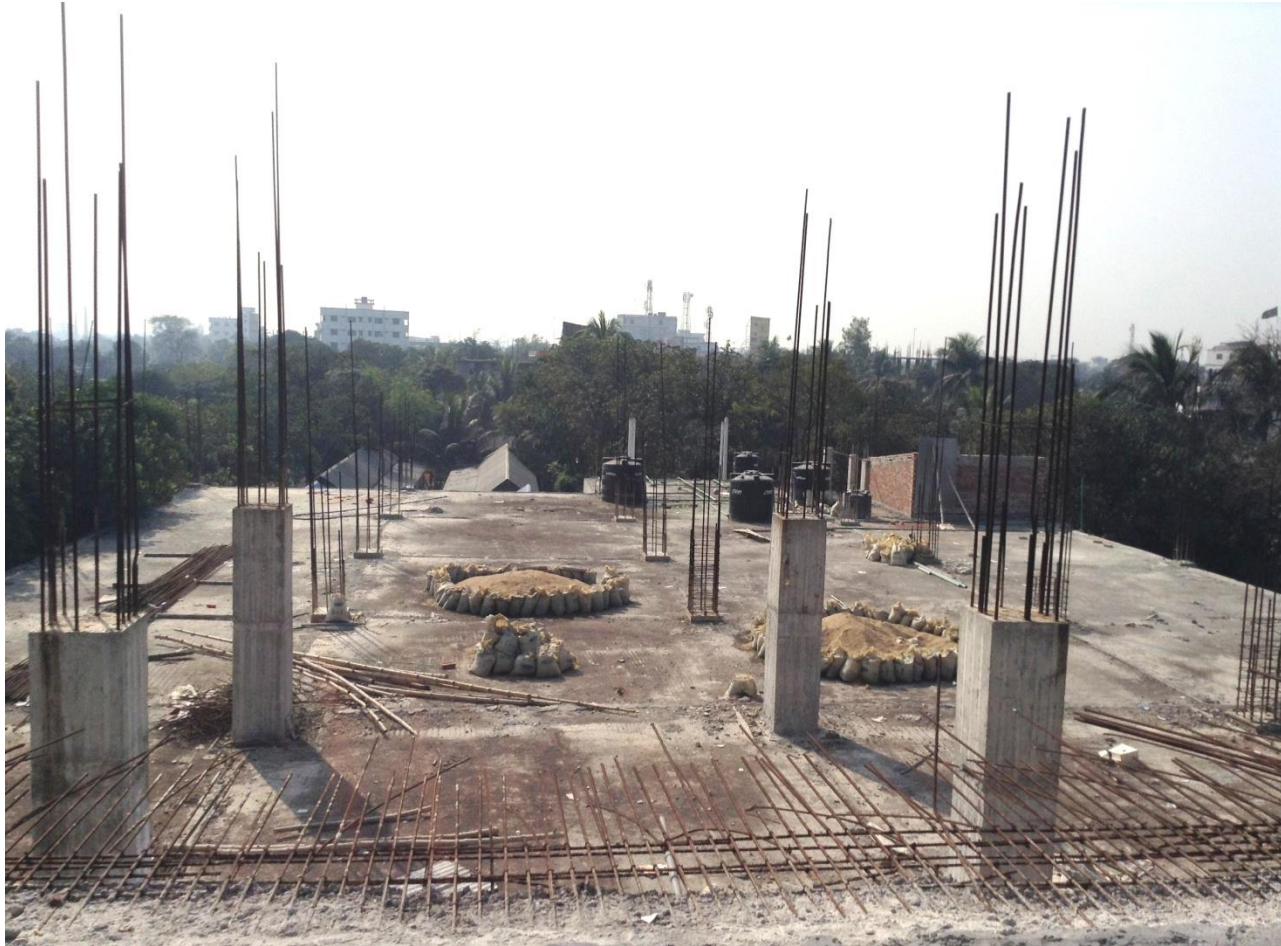
## Lack of edge protection

No edge protection was provided on the roof

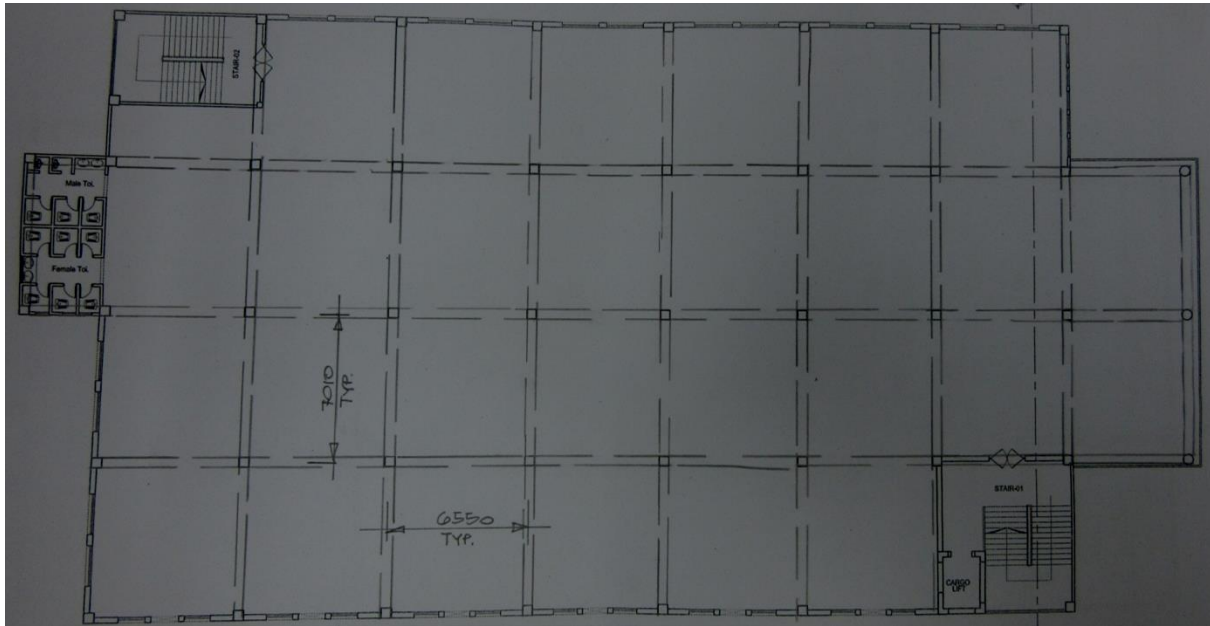
## High stress levels in columns

**High stress levels will exist  
in columns when all floor levels have been  
constructed**

The structural certificate provided indicates that the building design loads are :

Live Load 80psf

Typical floor finishes 25psf

Roof finishes 40psf.

Cursory calculations indicate that columns at Ground Floor level will be highly stressed when all floors (up to roof of 5<sup>th</sup> storey) have been constructed and are subjected to the floor loading noted above.

**ITEM 1: High stress levels in columns will exist when all floor levels have been constructed**

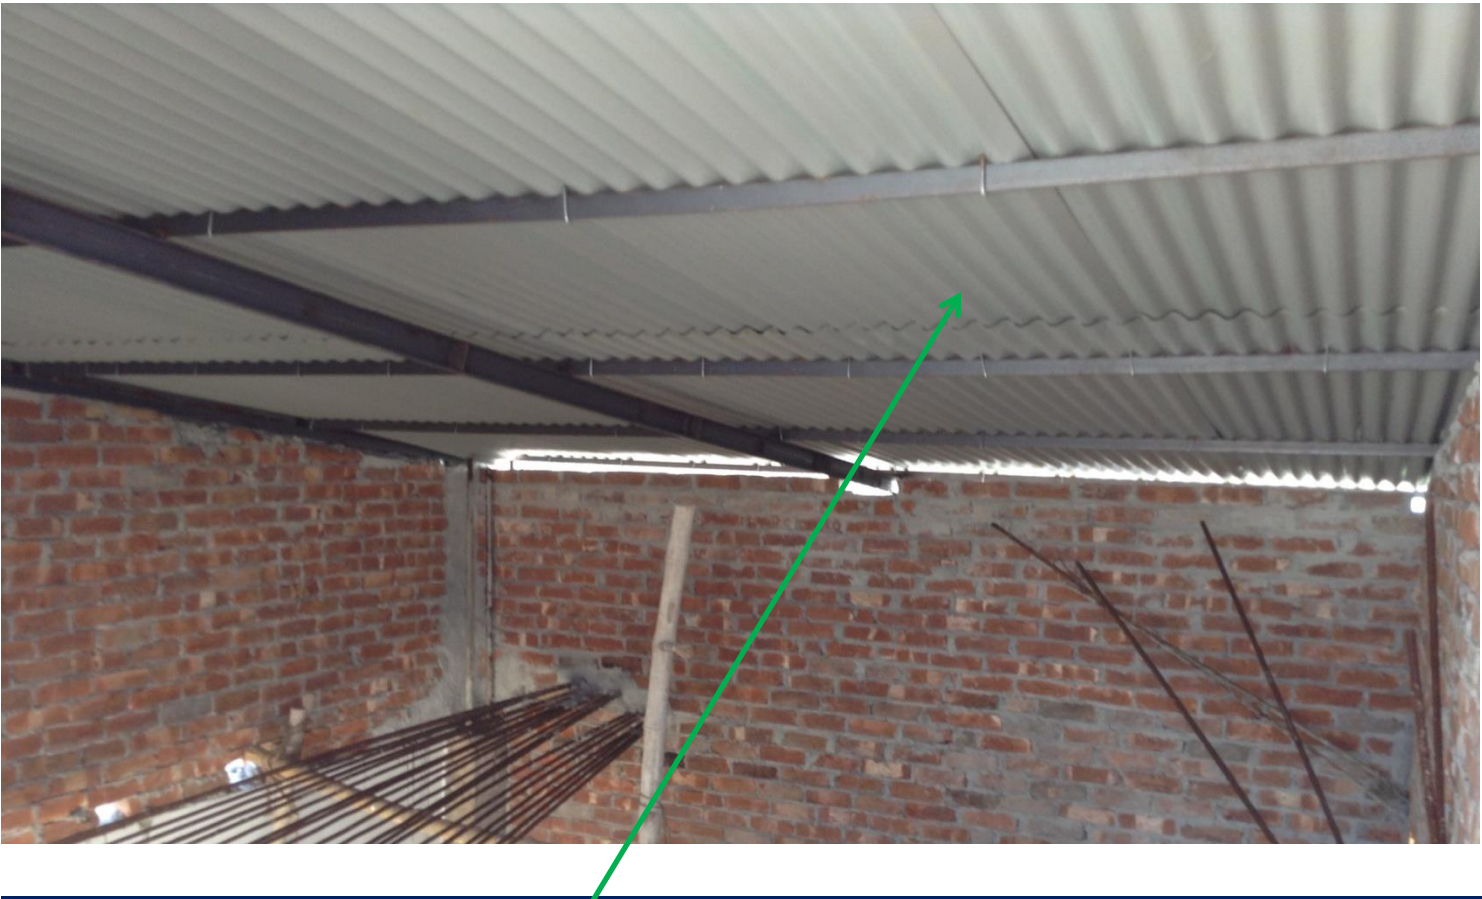
## Apparently non-engineered structures

Temporary corrugated steel sheeted structure over stair

**ITEM 2: Apparently non engineered roof structures**

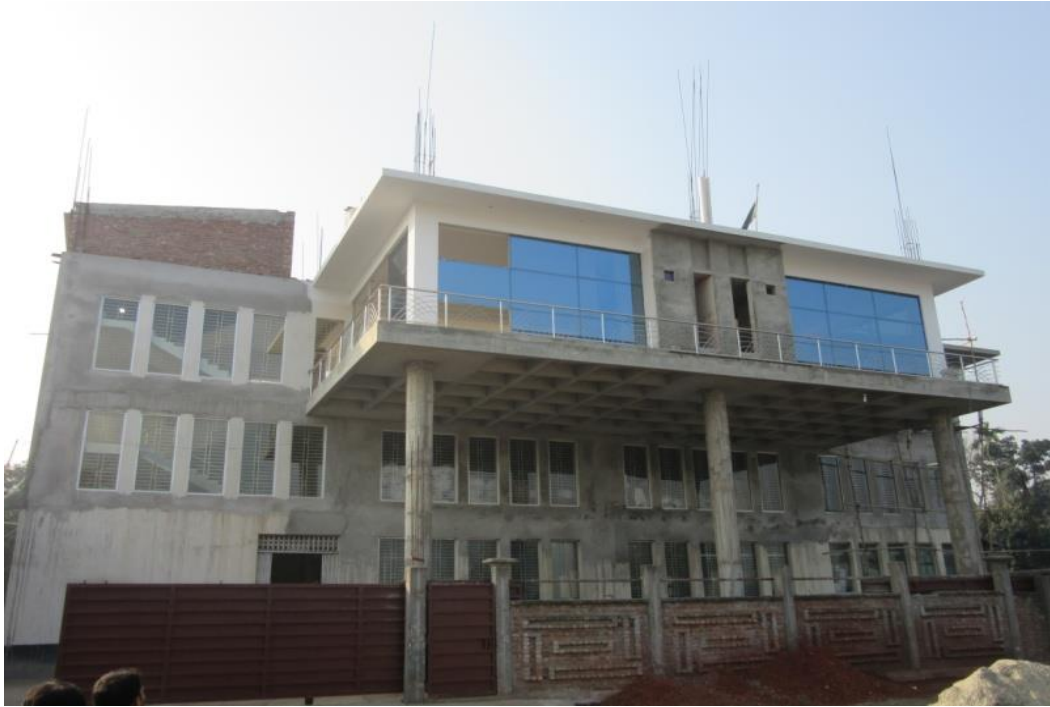
## North Elevation Columns

Columns Vulnerable to Impact Damage on North Elevation

**ITEM 3: Impact vulnerability to columns supporting 2<sup>nd</sup> / 3<sup>rd</sup> floor structure on North Elevation**
