ELECTRICAL SAFETY INSPECTION REPORT

ABM Fashions Ltd.

Inspected on 21 October 2015

ACCORD
on Fire and Building Safety in Bangladesh

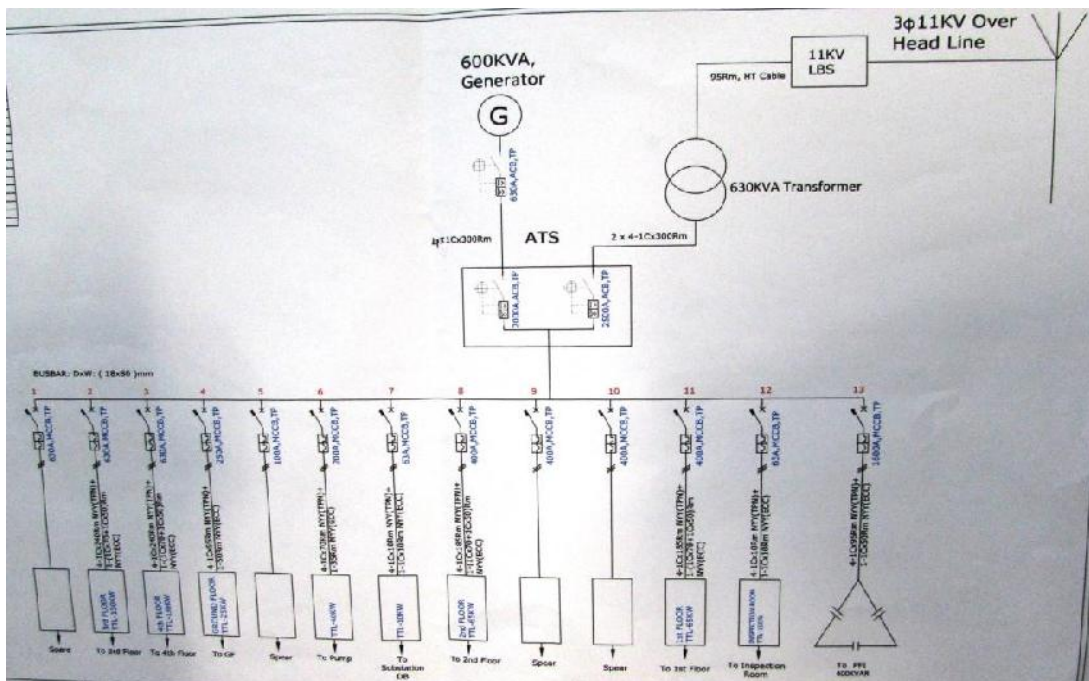
Figure 2: As-built SLD of Substation.

The factory officials presented the as-built SLD of substation and also the SLD of future expansion with 1250kVA transformer and two 600kVA diesel generators.

Transformer #1	
Owner	Factory owned
Location	Floor mounted transformer in the substation
Transformer Type	Oil immersed type
Arrangement	1 three-phase transformer
Single phase or 3 phase	3
Primary Voltage (kV)	11.0 kV
Secondary Voltage (kV)	0.42 kV
Capacity	630 kVA
Network System	3-Phase, 4-Wire

Generator #1	
Generator Type	Diesel
Capacity	600 kVA
Rated Voltage	415 V
Number of hours/day	3
Backup or Main supply	Backup power
