ABM Fashions Ltd

1143&1145, Konabari, Kashimpur Road, Gazipur
(24.004348N, 90.320706E)

27th October 2015

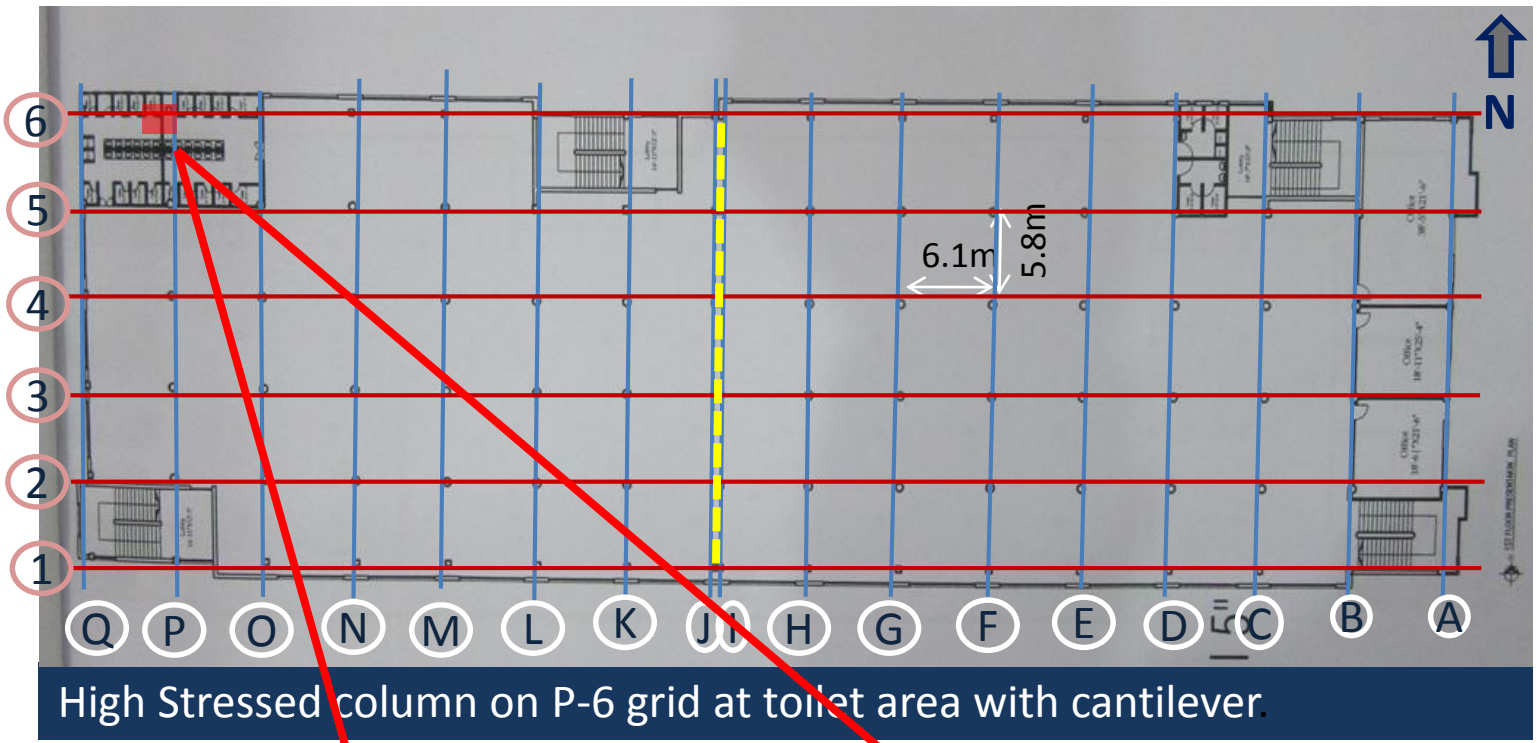
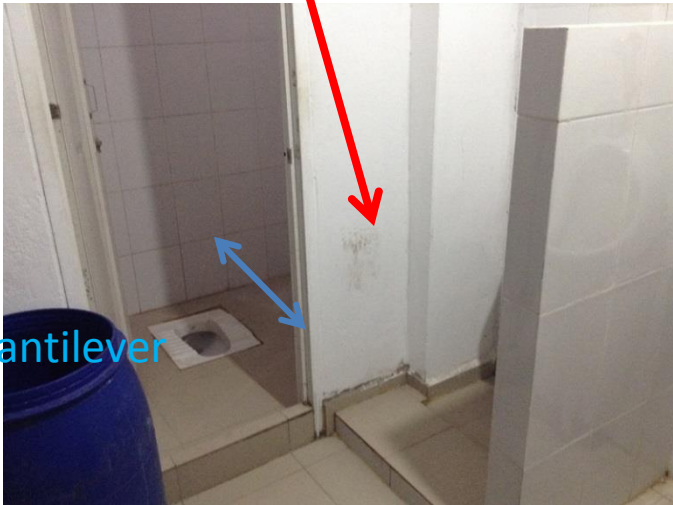
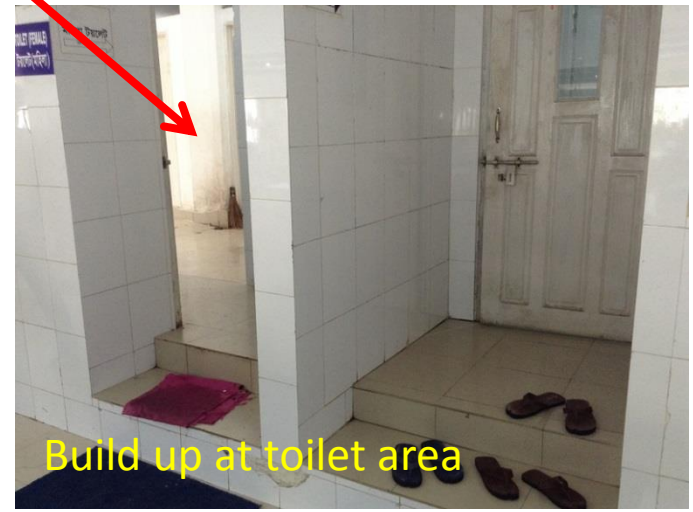
Highly stressed column due to finishes build up in toilet area.

ITEM 1: Highly stressed column at grid P6

| Item No. | Observation | Recommended Action Plan | Recommended Timeline |
|---|--|--|---|
| 1 | Column on grid P-6 appears to be critically stressed both in capacity and punching shear. Verify concrete strength in columns. | Do not carry out any further fit out works in the toilets in the area of column P6 until design check has been carried out. | Immediate - Now |
| 2 | Column on grid P-6 appears to be critically stressed both in capacity and punching shear. Verify concrete strength in columns. | Factory Engineer to carry out a detailed check on the loading and actual capacity of column on grid P6. A check is to be carried out on site to ascertain if shear reinforcement has been provided in the slab at the column head. | 6-weeks |
| 3 | Column on grid P-6 appears to be critically stressed both in capacity and punching shear. Verify concrete strength in columns. | Verify insitu concrete strengths either by 100mm diameter cores or existing cylinder strength data for column P-6. | 6-weeks |
| 4 | Column on grid P-6 appears to be critically stressed both in capacity and punching shear. Verify concrete strength in columns. | Make structural alterations if required as advised by Factory Engineer | 6-months |

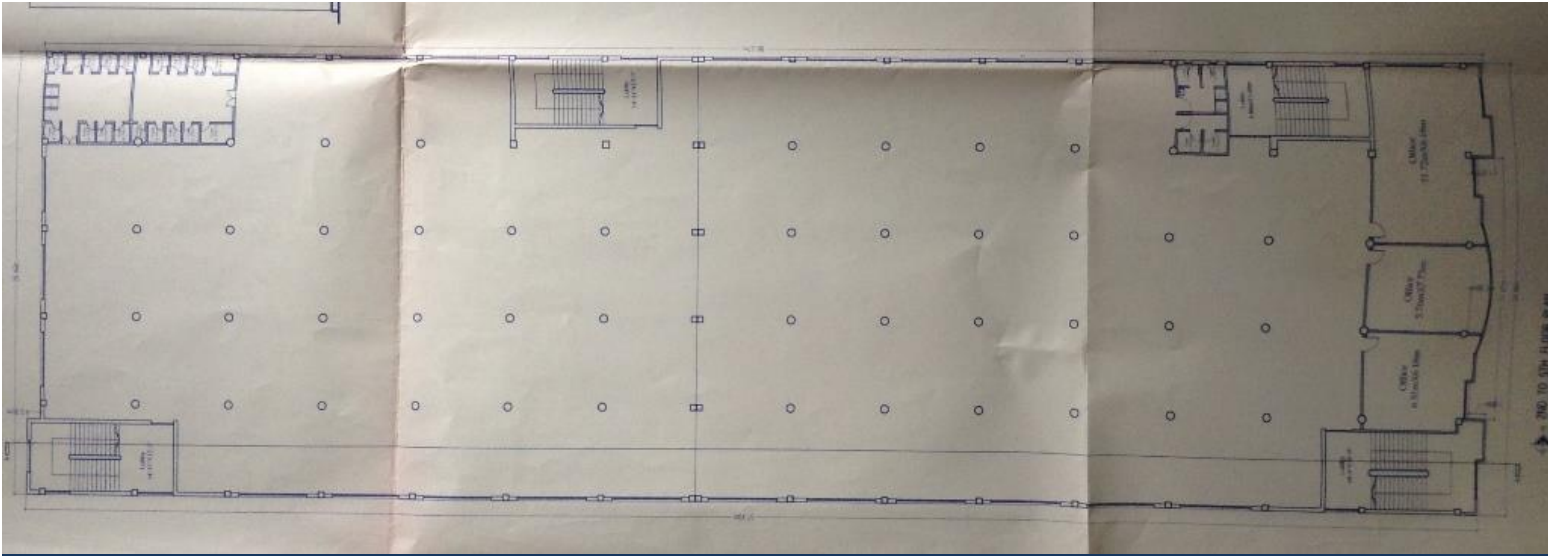
Permit drawing do not show cantilevers at north and south

ITEM 2: Discrepancy between drawings and existing structure.

| Item No. | Observation | Recommended Action Plan | Recommended Timeline |
|---|---|---|---|
| 5 | Discrepancies between drawings and as built structure. Possible punching shear problem on edge and central columns. | Factory Engineer to check on site if shear reinforcement has been put into the slab at column heads both at the perimeter and the middle of the slab. | Immediate - Now |
| 7 | Discrepancies between drawings and as built structure. Possible punching shear problem on edge and central columns. | Factory Engineer to fully compare the building drawings with the as-built structure. | 6-weeks |
| 8 | Discrepancies between drawings and as built structure. Possible punching shear problem on edge and central columns. | Update drawings to fully record the as-built condition of the building. | 6-months |

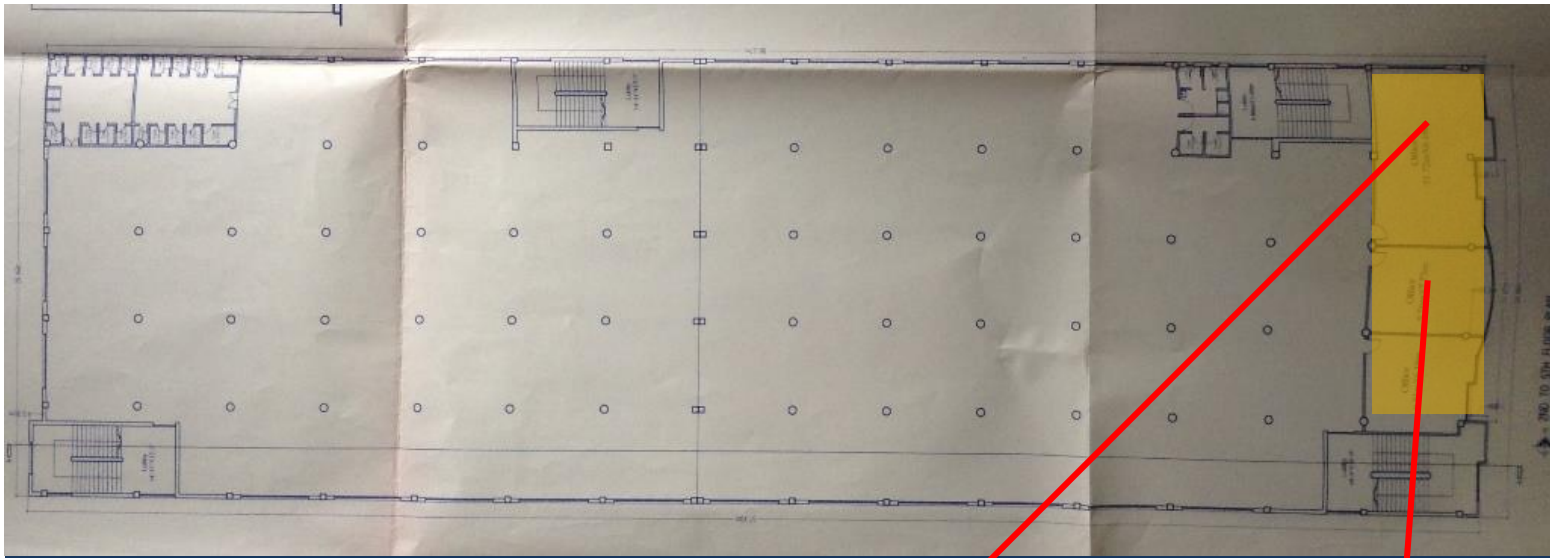
Uncontrolled storage at 5th floor (shown in amber)

| Item No. | Observation | Recommended Action Plan | Recommended Timeline |
|---|---|---|---|
| 9 | Actively manage and implement existing load plan. | Factory Engineer to review loads on floor areas. | 6-weeks |
| 10 | Actively manage and implement existing load plan. | Actively manage existing loading plan for all floor plates within all buildings, giving consideration to floor capacity and column capacity. | 6-weeks |
