# FIRE SAFETY INSPECTION REPORT

**Factory Name: ABSS High Tech Sweater Ltd.**

**ACCORD ID: 12407**

**Date: 10 May 2016**

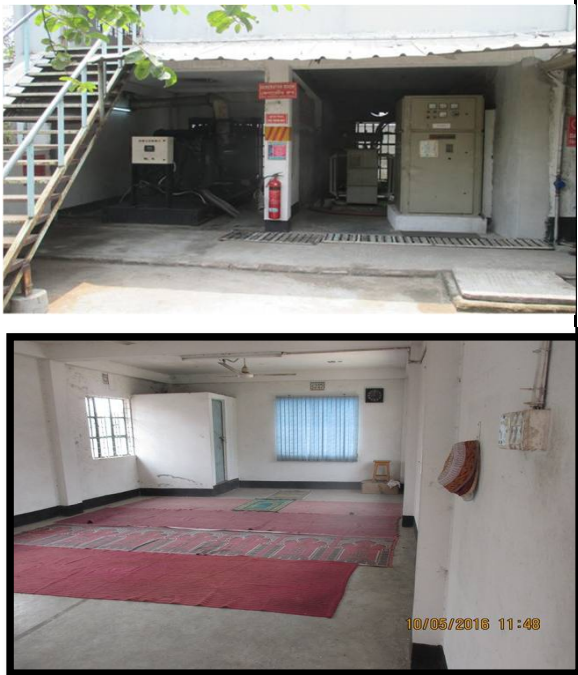
SI No.	Category	Findings	Required Action	Remediation Time Frame	Pictorial Evidence
1	Fire Rated Construction	Generator/ transformer room is not properly separated by fire rated construction from the stair which is used for going to the prayer room at south-east corner of the factory premises.	<p>Generator/ transformer room shall be separated from the stair by a minimum 2-hr fire rated construction (wall, floor, slab etc.). Seal all penetrations and openings (door, window etc.) shall be protected by 1.5-hr fire rated materials to maintain the fire separation if required. All exhaust systems shall discharge to the exterior of the building in a safe location.</p> <p>Or, relocate the prayer room in a safe place.</p>	Within 3 months

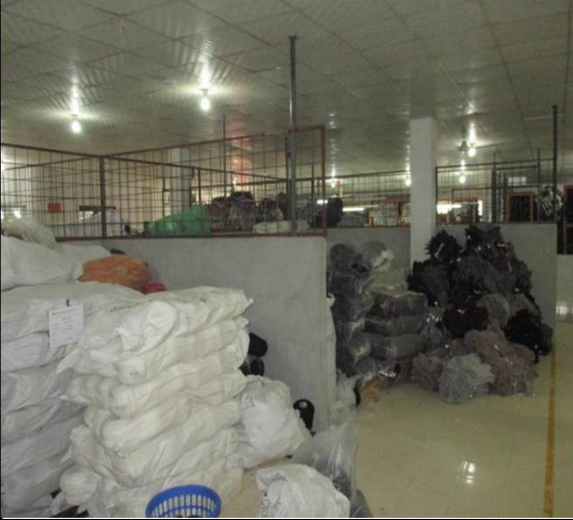
SI No.	Category	Findings	Required Action	Remediation Time Frame	Pictorial Evidence
2	Fire Rated Construction	Areas used for in-process storage of combustible materials are open to the surrounding occupancy	Provide defined storage areas and limit the storage arrangement as: Maximum height of 2.4m and maximum area of 23m <sup>2</sup> . Separate areas of unenclosed combustible storage by a minimum clear distance of 3m	Within 3 months

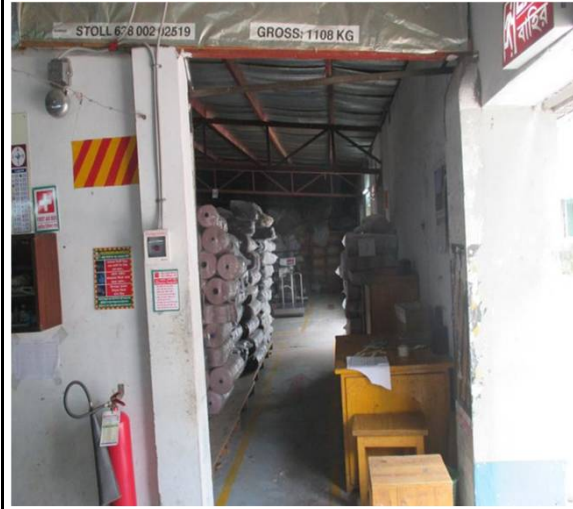
3	Fire Rated Construction	Room used for storage of combustible materials (yarn store) is not separated from the surrounding occupancy (winding section, office)	Rooms used for storage of combustible materials shall be separated from the surrounding occupancy with a minimum 1 hour construction.	Within 3 months

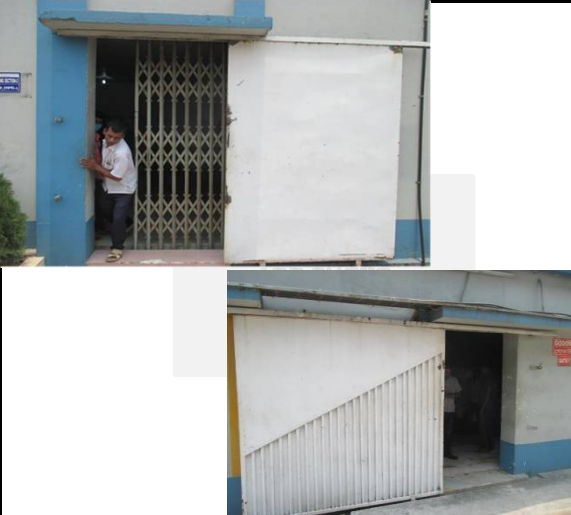
SI No.	Category	Findings	Required Action	Remediation Time Frame	Pictorial Evidence
4	Egress	Collapsible/ sliding type doors have been provided along means of egress (building exits, along egress routes, exit discharge).	<p>Replace all collapsible/ sliding type doors &amp; gates by the side-hinged swinging type doors.</p> <p>If locks are required for security reasons, utilize special door locking features complying with NFPA 101.</p>	Within 1 month

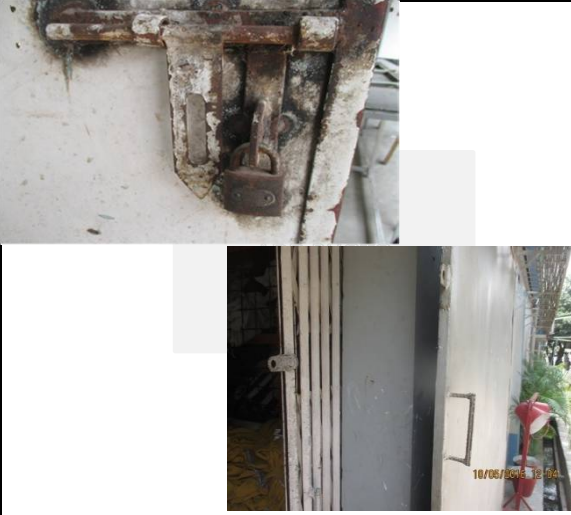
5	Egress	Doors along means of egress are provided with non compliant locking system	<p>1. Remove all non compliant locking features from egress doors.</p> <p>2. If locks are required for security reasons, utilize special door locking features complying with NFPA 101.</p>	Immediate

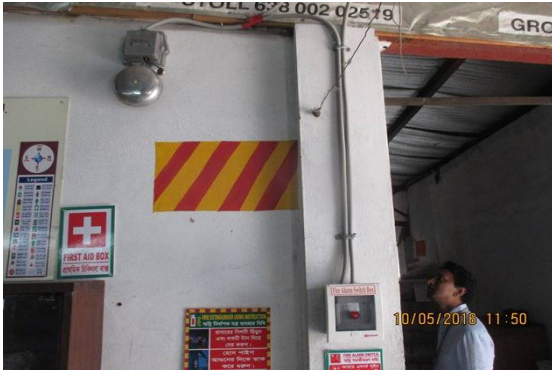
SI No.	Category	Findings	Required Action	Remediation Time Frame	Pictorial Evidence
6	Egress	Building did not have occupant load signs at required locations.	Provide occupant load signs at required locations.	Within 1 month	
7	Fire Alarm System	The existing fire alarm system is not a listed system and does not provide automatic alarm and notification features consistent with acceptable standards	Remove single station smoke alarms. Replace the fire alarm system with a new, listed automated fire alarm system in accordance with NFPA 72	Design within 4 months; install within 9 months

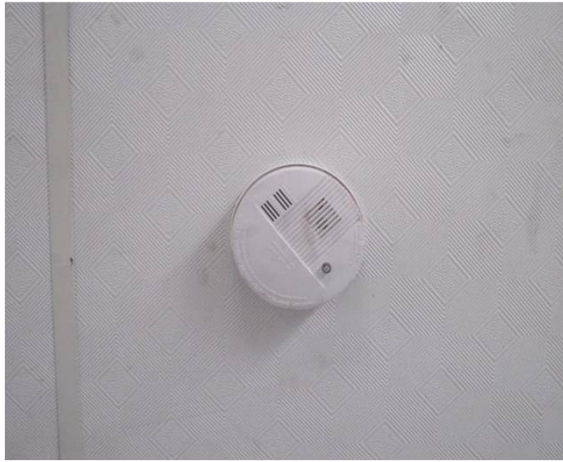
SI No.	Category	Findings	Required Action	Remediation Time Frame	Pictorial Evidence
8	Fire Alarm System	Inspection, testing, and maintenance for the fire alarm system is not in accordance with NFPA 72 or as per Accord standard.	Inspect, test and maintain the fire alarm system, and keep written records on-site, in accordance with NFPA 72 or as per Accord standard.	Within 3 months

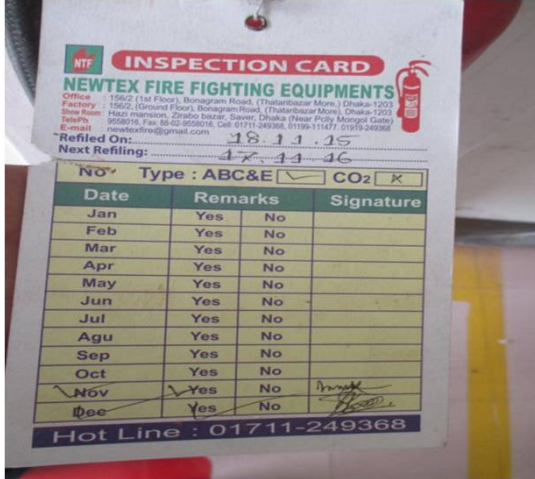
9	Fire Protection	Inspection, testing and maintenance of portable fire extinguishers is not in accordance with NFPA 10.	Inspect, test and maintain the portable fire extinguishers and keep written records on-site, in accordance with NFPA 10 and ACCORD standards.	Within 3 months

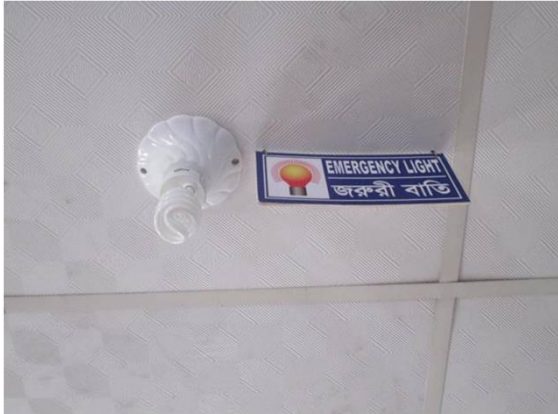
SI No.	Category	Findings	Required Action	Remediation Time Frame	Pictorial Evidence
10	Emergency Egress Lighting	Based on the number and location of emergency lights observed, adequate illumination levels are not anticipated along egress routes.	Test the emergency lighting system on each floor and provide additional emergency fixtures to provide adequate illumination along the means of egress. Provide a minimum illumination of 10 lux at the floor level within exit stairs and exit discharge paths and minimum 2.5 lux along exit access aisles.	Within 3 months

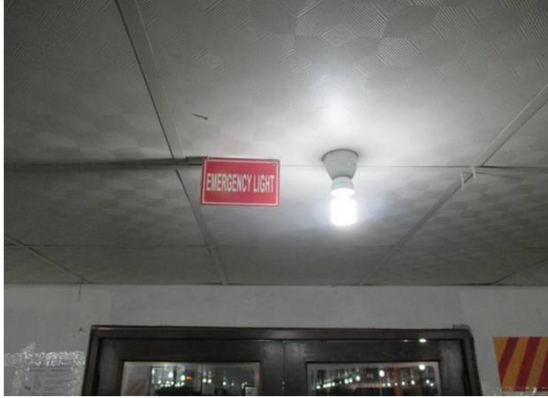
11	Inspection, testing and maintenance	Inspection, testing, and maintenance for the exit sign and emergency lighting system was not in accordance with The ACCORD standard.	Inspect, test and maintain the exit sign and emergency lighting system in the accordance with The ACCORD standard. Keep written records on-site.	Within 3 months
