ABSS High Tech Sweater Ltd.

10 May, 2016

Client Summary Report

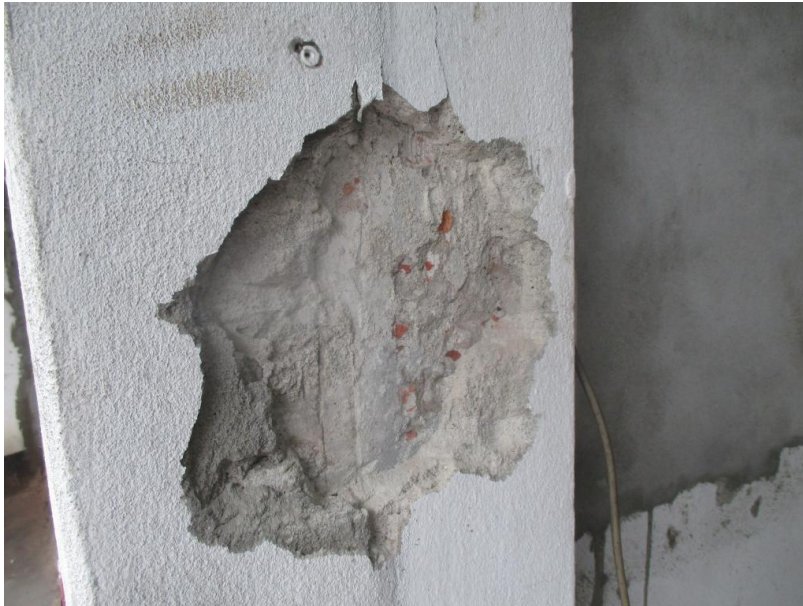
Aggregate type and rebar checking
