# ABSS High Tech Sweater Ltd.

Kalameshar, Board Bazar, Gazipur

10 May, 2016

## Client Summary Report

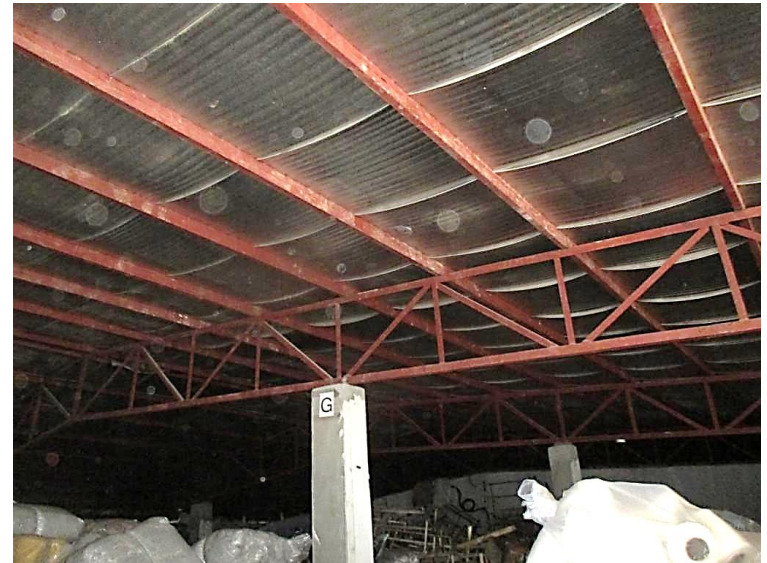
# Stability check for Non-engineered steel roof against lateral load

Steel shed appears to be non-engineered (no apparent lateral stability system, apparently non engineered connections)

- The Building Engineer shall provide calculations showing the structural adequacy of non-engineered steel shed against lateral force

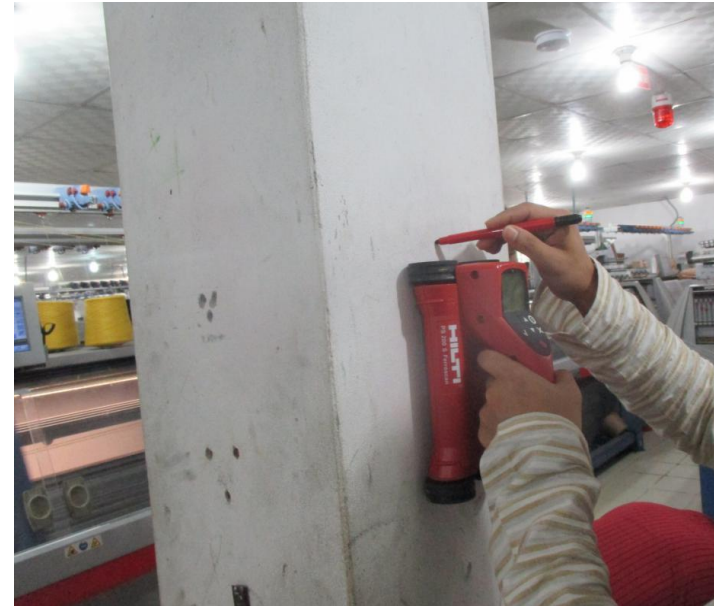
# Test Carried out

## Aggregate type and rebar checking
