FIRE SAFETY INSPECTION REPORT

A. G. DRESSES LTD.

**TONGI INDUSTRIAL AREA, HIMARDIGHI, TONGI,
DHAKA**

March 1, 2014

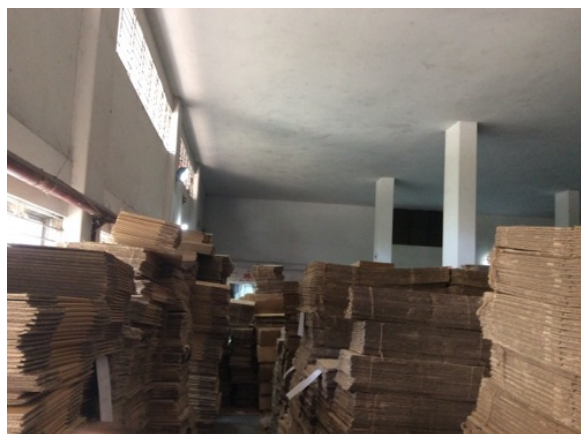
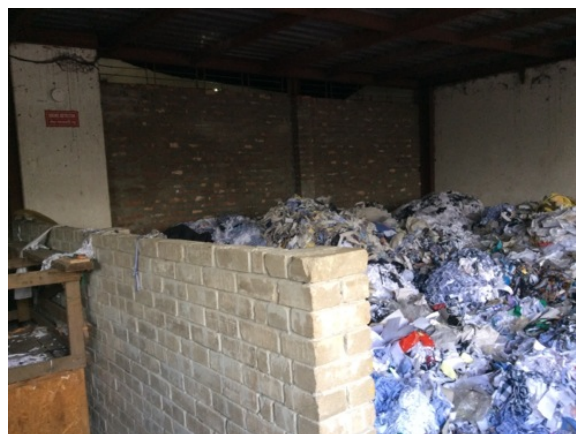
No.	Category	Finding	Recommendation	Remediation Timeframe
F-1	Fire Rated Construction	Areas used for combustible storage are not separated by fire- rated construction. Locations: Ground Floor Mezzanine Floor	Provide dedicated storage rooms separated by minimum 1-hr fire-rated construction.	Within 3 months

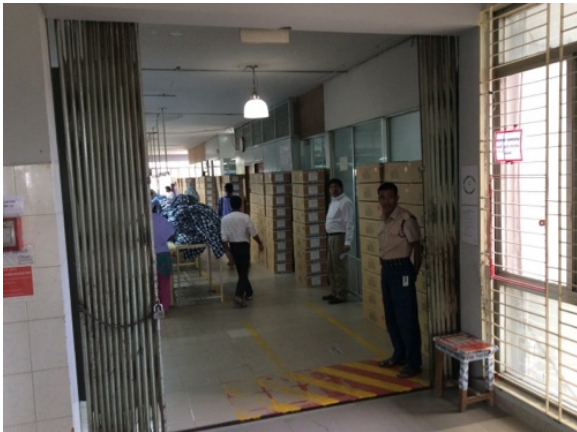
F-2	Fire Rated Construction	The exit stairs are not separated from work areas and other spaces on each floor by fire-rated construction.	Provide minimum 1.5-hr fire rated doors and seal all unprotected openings to separate the exit stairs from work areas and other building spaces on all floor levels. Ensure that the fire doors are self-closing and positive latching and that they are provided with fire exit (panic) hardware where serving production floors. If fire doors are required to be held open for functional reasons, provide automatic-closing devices tied to the fire alarm system.	Within 3 months
-----	-------------------------	--	---	-----------------

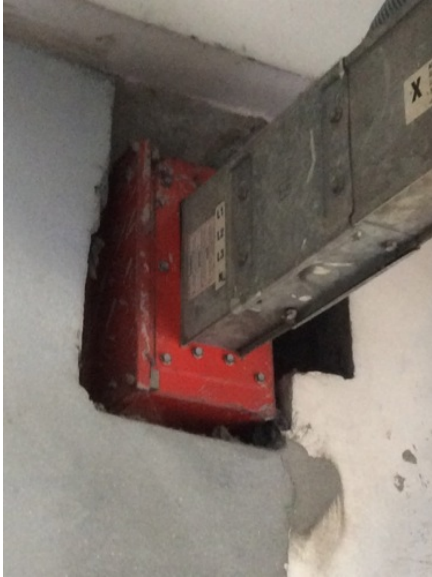
F-3	Fire Rated Construction	Unsealed penetrations and openings are located in the fire-rated floor/ceiling assemblies.	Provide a minimum 2-hr fire-rated shaft to separate the utility risers from each floor level.	Within 3 months
-----	-------------------------	--	---	-----------------

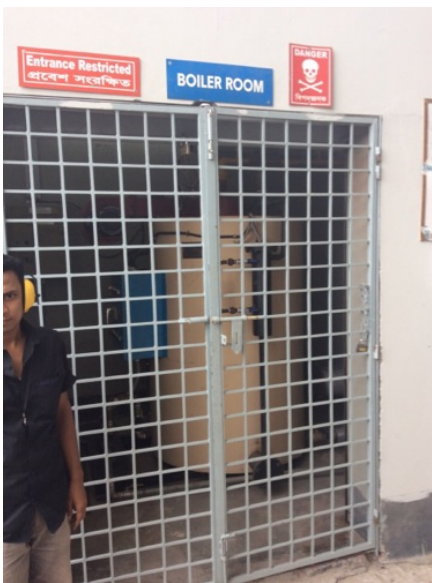
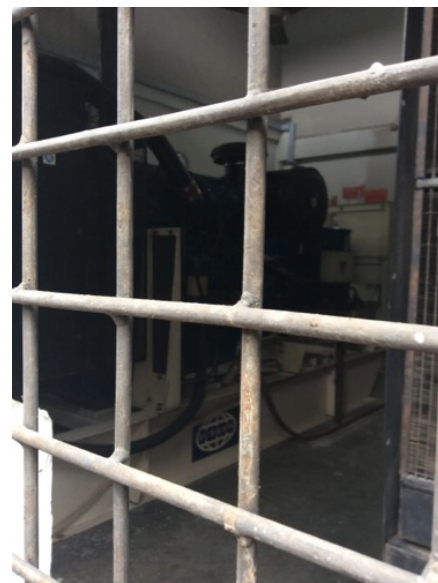
F-4	Fire Rated Construction	<p>The boiler and generator rooms are not separated by fire-rated construction (openings, non-rated doors, penetrations).</p> <p>They are open to egress paths.</p>	<p>Separate the boiler and generator rooms by a minimum 2-hr fire-rated construction. Seal and/or protected all openings to maintain the required fire separations</p>	<p>Within 3 months</p>
-----	-------------------------	---	--	------------------------

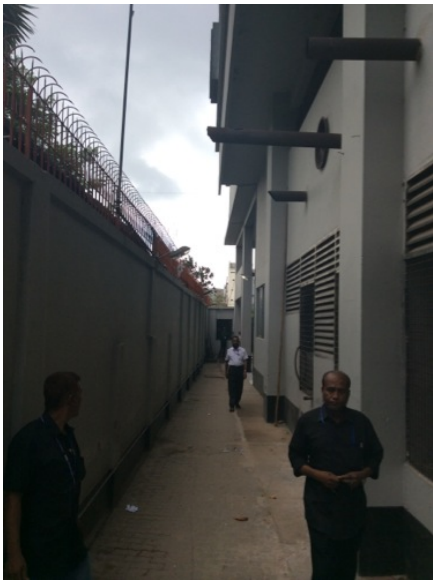
F-5	Fire Rated Construction	The exit discharge path serving NW exit is less than 10 ft wide and is not separated from the building interior.	Seal all penetrations and openings to the interior of the building along the discharge path, up to a height of 10 ft., to provide a minimum 1-hr fire separation. Alternatively, provide a second remote discharge path to the public way (only include this if feasible).	Within 6 months
-----	-------------------------	--	---	-----------------

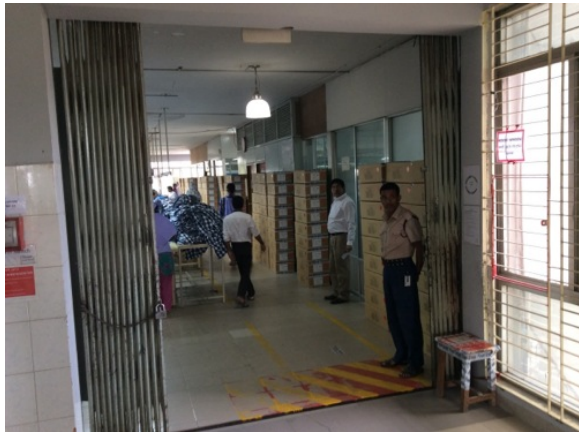
F-6	Egress	Egress doors / gates with locking features are provided at building exits, exit stairs, along egress routes, and exit discharge.	Remove locking features from all egress doors / gates. If locks are required for security reasons, utilize special door locking features complying with NFPA 101.	Immediate
-----	--------	--	--	-----------

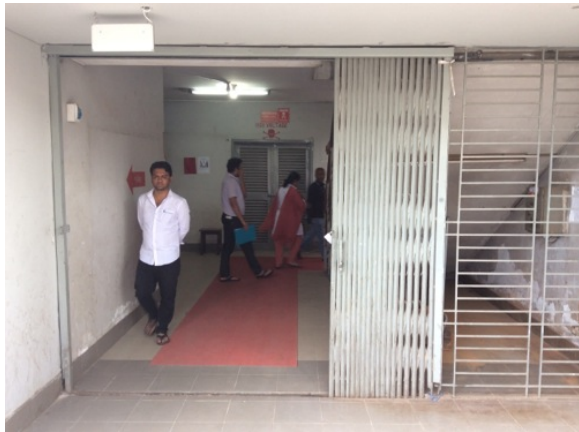
F-7	Egress	Storage was located in the North West exit stair.	Remove all storage from exit stairs and egress paths.	Immediate
F-8	Egress	Collapsible gates / sliding doors are provided at building exits, exit stairs, along egress routes, exit discharge.	<p>Replace all gates / sliding doors along the means of egress with side-hinged, swinging egress doors.</p> <p>If locks are required for security reasons, utilize special door locking features complying with NFPA 101.</p>	Within 1 month

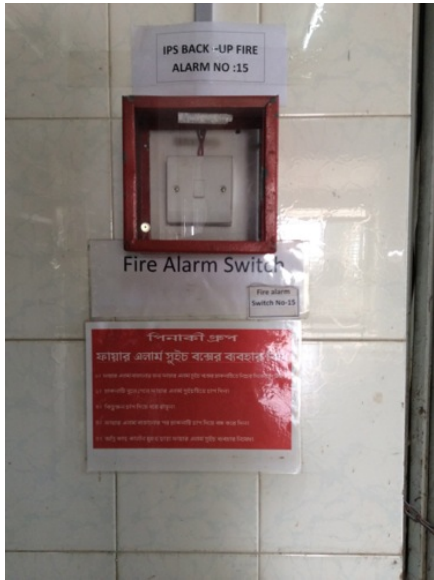
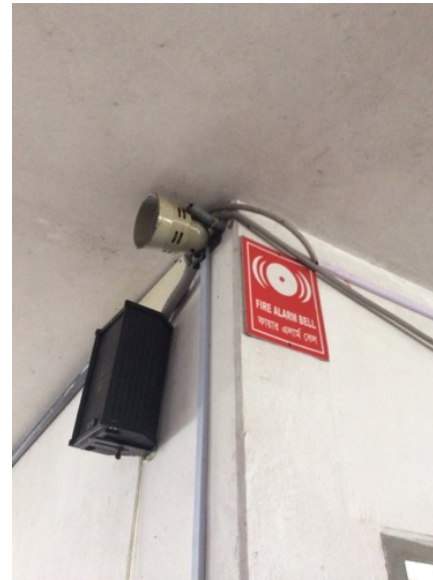
F-9	Egress	Exit capacity for the 6th floor is not adequate for the occupant load.	Reduce occupant load to not more than available exit capacity (676).	Within 3 months
		Occupant Load - 890 Capacity - 676		
F-10	Fire Protection	The fire alarm system is antiquated, not a listed system, and does not provide alarm and notification features consistent with acceptable standards.	Replace the fire alarm system with a new, listed addressable fire alarm system in accordance with NFPA 72.	Design within 4 months, install within 9 months

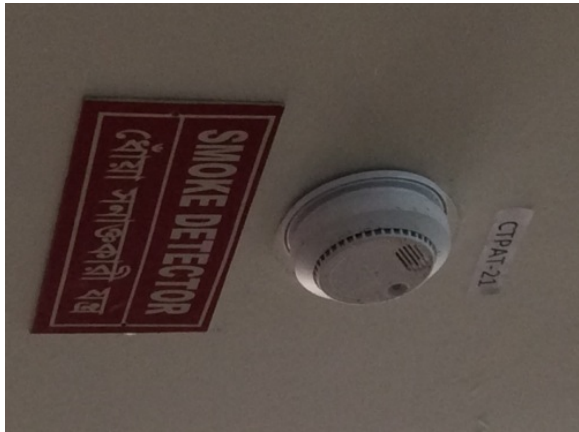
F-11	Fire Protection	Inspection, testing, and maintenance for the fire alarm system it was not in accordance with NFPA 72.	Inspect, test and maintain the fire alarm system, and keep written records on-site, in accordance with NFPA 72.	Within 3 months
F-12	Fire Protection	The building is equipped with single-station smoke alarms. Smoke alarm activation sounds only a local alarm and does not provide automatic fire alarm notification of occupants.	Remove single-station smoke alarms. Provide automatic smoke detection throughout the building in accordance with NFPA 72.	Within 6 months
