**Majumder Garments Ltd (9380)**

Plot #415-417, Hariarpara, Panchabati, Fatullah, Narayanganj

25.May.2014

## Identified Priority 1 Concerns

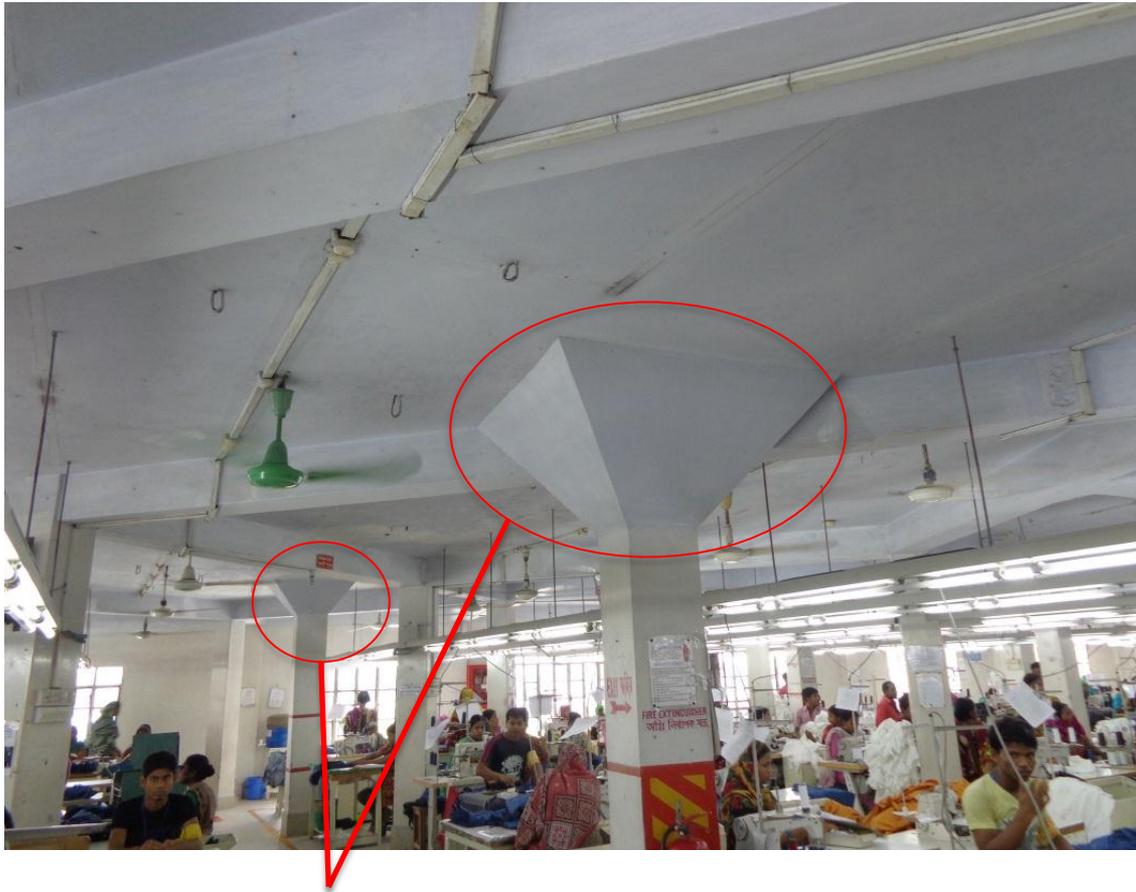
Columns rebar does not match documentation provided;  
loading to be reduced to acceptable stress levels

We surveyed a typical 250 mm x 300mm column. Two columns were Ferroscored. One showed 6 bars and the other showed 8 bars. We estimated the bars at 16mm, as per as-built drawings.

Loading on typical column reflects approx. 2 kPa. High brick partitions with plaster on both sides are also found certain areas of building.

Both columns were in the new section of the building. We were unable to ferroscore a column in the original building due to all the partition.

Example of what we believe to be a column dated from 2001 that goes down to the foundation level

We require a full Detailed Engineering Assessment.

Item No.	Observation	Recommended Action Plan	Recommended Timeline
1	Main building – Columns rebar does not match documentation provided; loading to be reduced to acceptable stress level .	Reduce all storage on all floors to 2kPa. Verify in-situ stress and material properties by testing 100mm dia. Concrete cores of 4 columns. Commence Detailed Engineering Assessment.	Immediate - Now
2	Main building – Columns rebar does not match documentation provided; loading to be reduced to acceptable stress level .	Create and actively manage loading plan for all floors by putting a signage and have a factory warden to ensure that these rules are followed throughout the factory.	6-weeks
3	Main building – Columns rebar does not match documentation provided; loading to be reduced to acceptable stress level .	Maintain the loading plan.	6-months
4	Main building – Brick columns shown on As-Built Drawings to support the roof.	Engineer to verify the capacity of the brick columns to resist gravity and lateral loads. (Include in DEA).	Immediate - Now

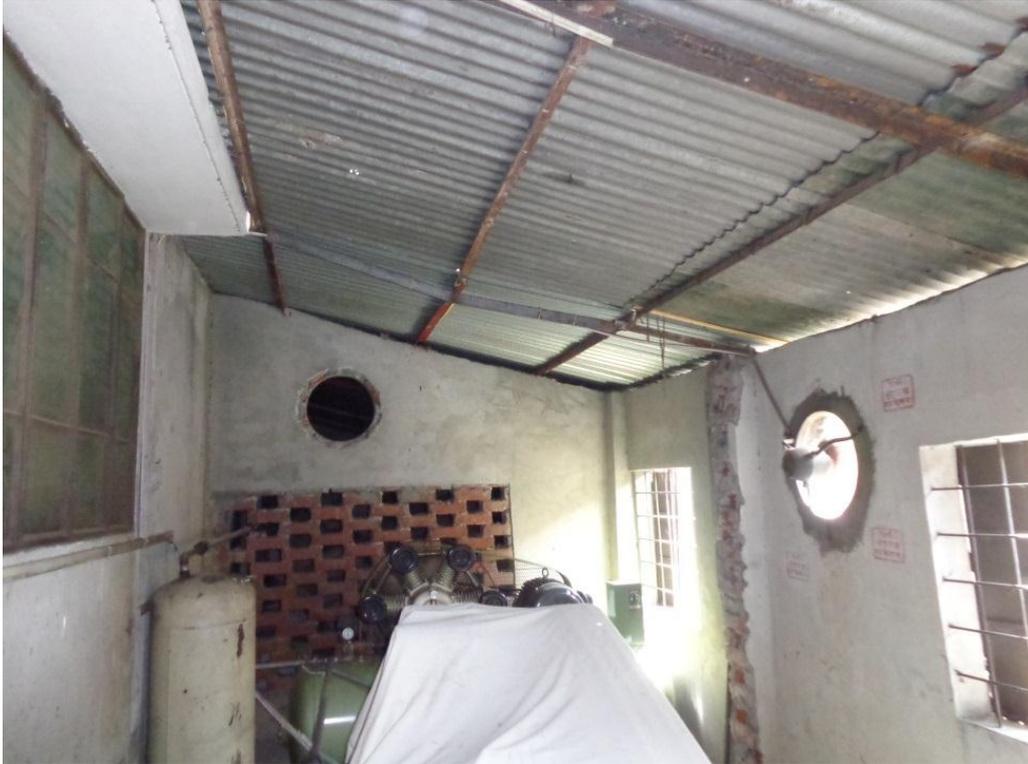
Auxiliary dormitory sheds in the courtyard are flimsy

Since the sheds house workers of the factory and are poorly constructed. They should be reinforced or strengthened to prevent them from being a danger during high winds or earthquakes.

5	Main building – Brick columns shown on As-Built Drawings to support the roof.	Carry out any remedial work deemed necessary by the DEA.	6-weeks
6	Auxiliary dormitory sheds in the courtyard are flimsy.	Reinforce structural elements to resist gravity loads & lateral loads for all sheds in the courtyard.	6-weeks
7	Main Building - As-Built documentation is incomplete.	Update As-Built drawing in order to provide more information with regard to the following elements: - Water tank at roof - Original vs Extension - 3rd Floor structural system (grid spacing, column size & materials) - Planter and tree loading information on 1st floor roofs.	6-weeks

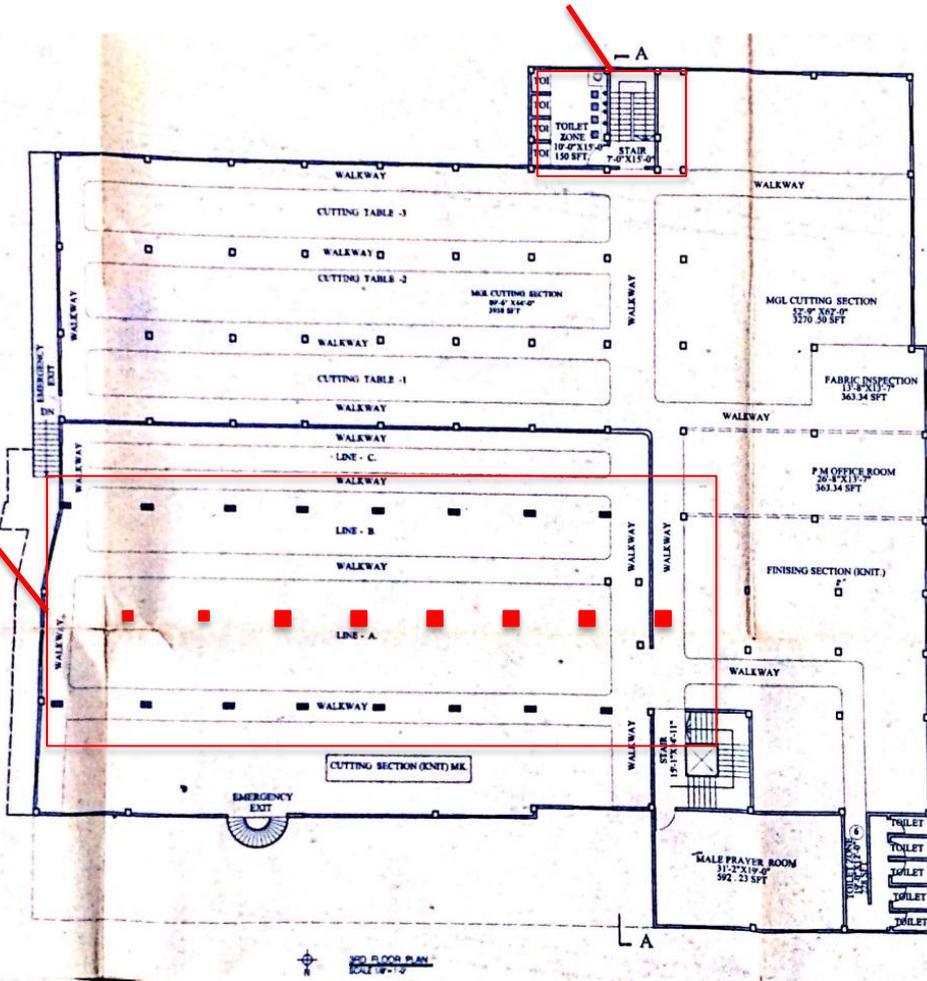
Water tank at roof

Column spacing is inaccurate

During our survey, we found that the As-Built drawings had some inaccurate information and missed some critical elements.

For example, we found a tighter grid spacing at the 3<sup>rd</sup> floor. We also found a water tank above one of the staircases.

Finally, the As-Builts should show the difference between the original building and the new building. The new drawings should also mention allowable loads of particular areas like the green roof which carry heavy loads like planters and trees.

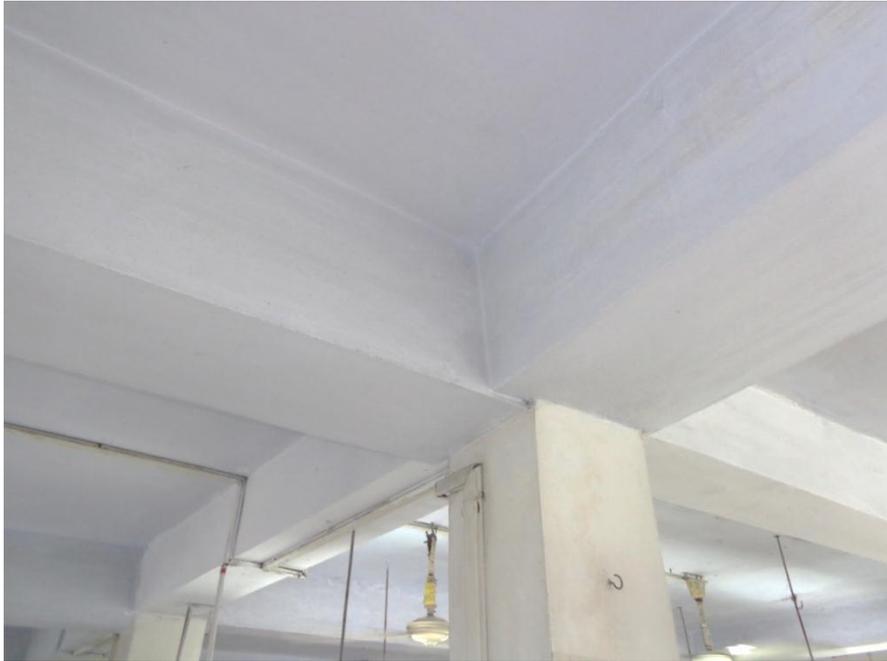
Low sway stability of building could probably be expected from rigid frame system (beam and column participation) although no ductile detailing is provided in structural plans. Furthermore, due to the compression stress in the columns, we are concerned that there is no reserve for flexural stresses due to lateral loads.

Periphery brick infill walls are unrestrained and should not be considered.

Finally, the brick columns shown on the current As-Built drawings have limited ductility and are expected to fail in case of a major earthquake.

**We require that these items be investigated in a Detail Engineering Assessment**

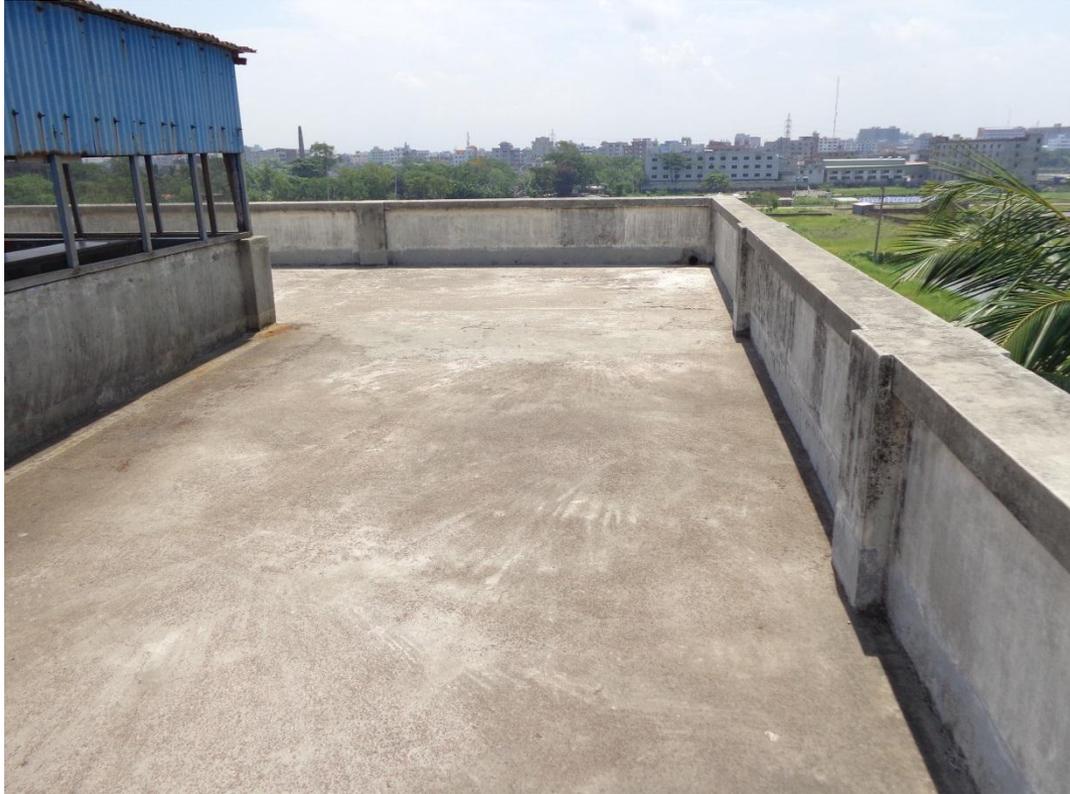
No waterproofing membrane was visible on the roof of the building. This means that any cracks in the surface finishes on the roof will allow water to seep into the concrete slab beneath the finishes, and cause long-term soaking of the slab. Same goes for water tanks at roof.
