ELECTRICAL SAFETY INSPECTION REPORT

ABM Fashions Ltd.

Inspected on 21 October 2015

ACCORD
on Fire and Building Safety in Bangladesh

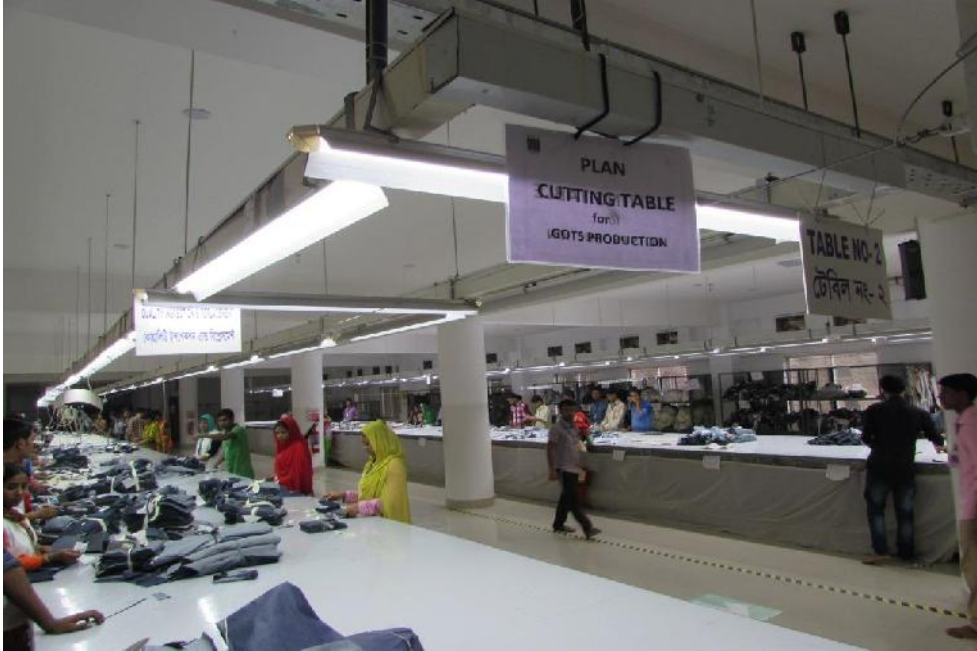
Figure 3: Electrical Installation on the factory floor.

The cabling systems in the factory are mostly supported in cable raceways made of aluminum channels above the working tables. However, some sections of distributions are made through surface PVC conduit and concealed conduit wires.

The cable raceway and electrical panel installation works were ongoing on 1st and 5th floors at the time of inspection.
