PICARD Bangladesh Ltd.

1143&1145, Konabari, Kashimpur Road, Gazipur
(23.910861N, 90.302220E)

3rd November 2015

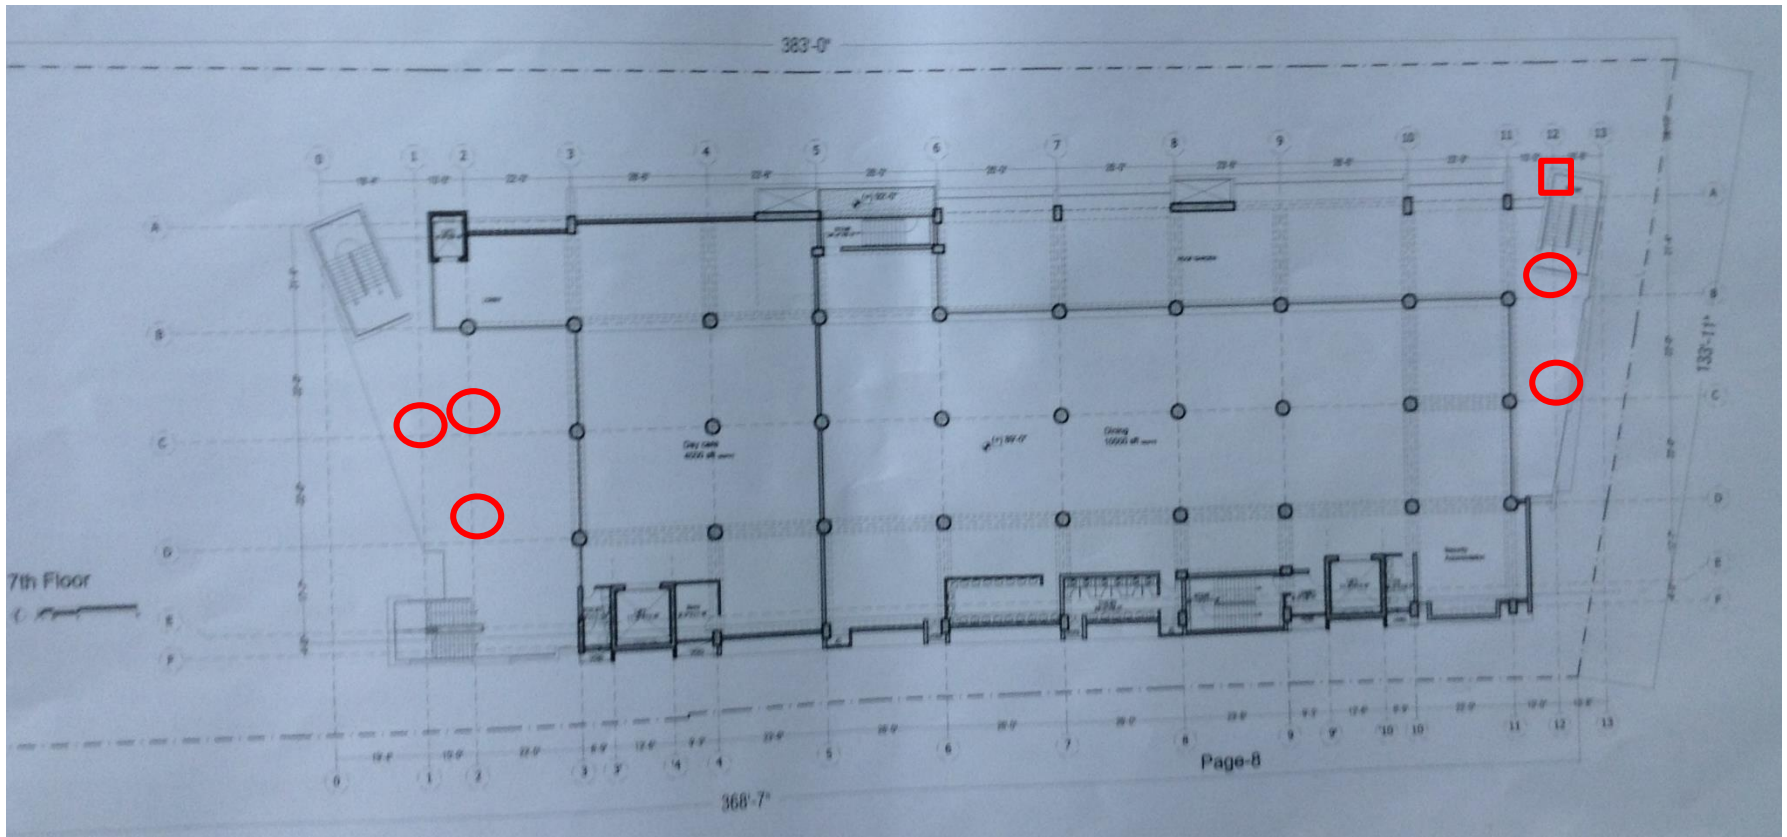
Discrepancies between site observations and information on drawings

Columns are not shown in Architectural Drawing for 7th Floor Presented in Structural Drawing and found in Present Condition.

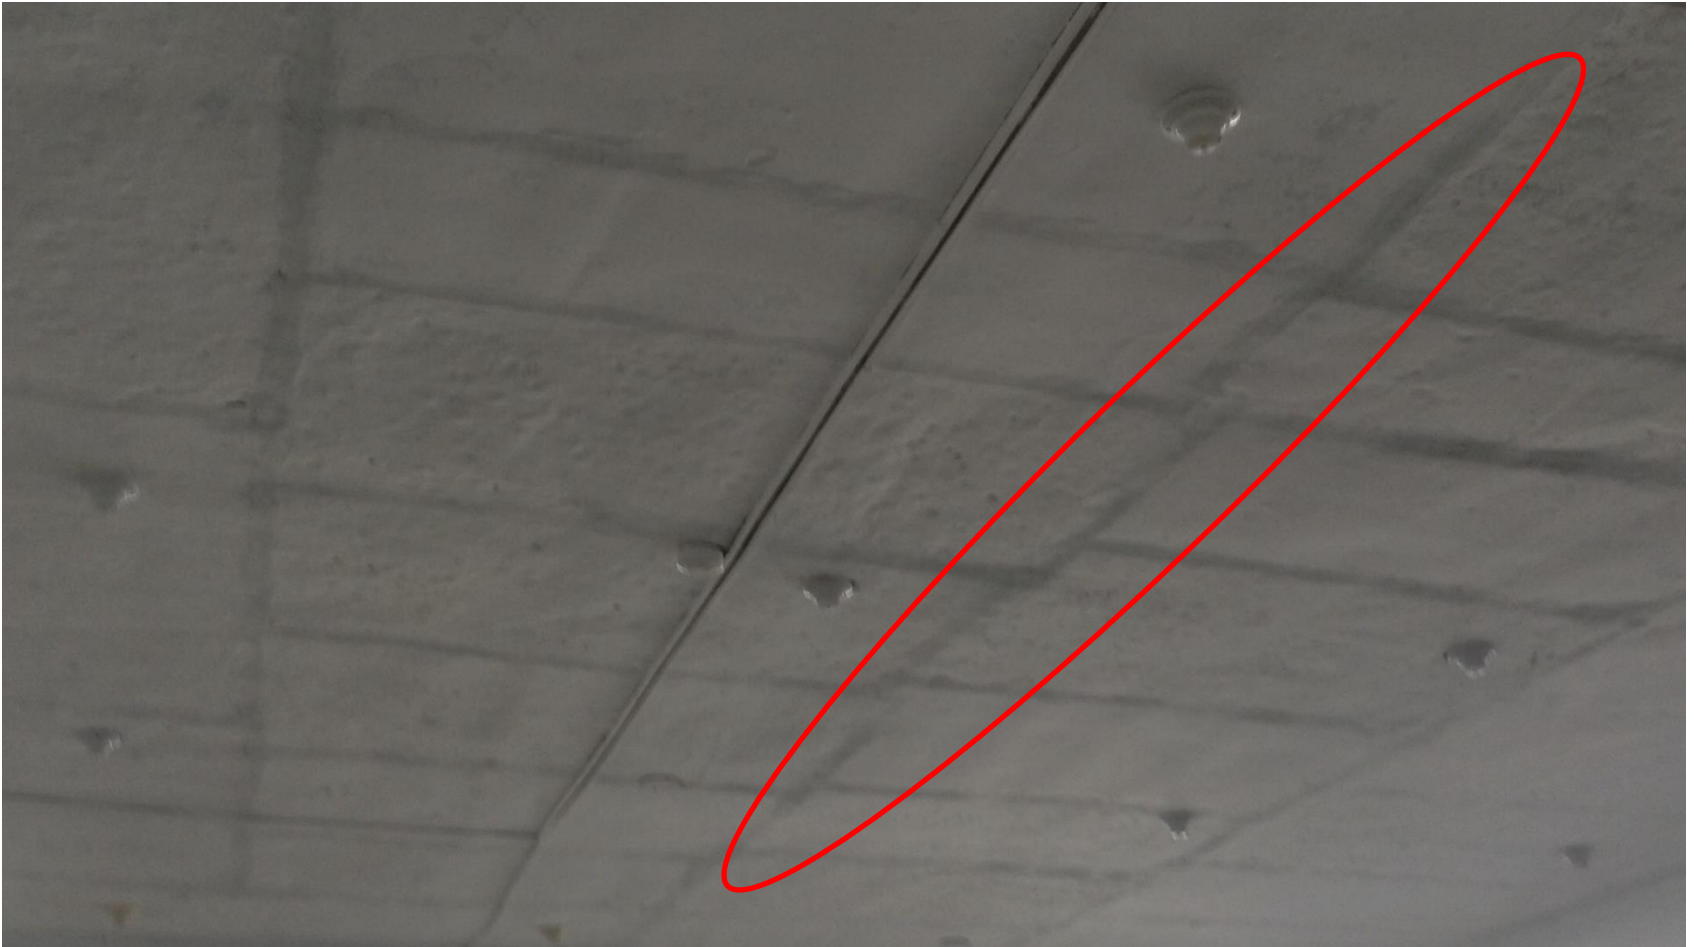
Poor Construction Work on Roof Shuttering

Poor Construction Work on Roof Shuttering causes uneven Slab Surface

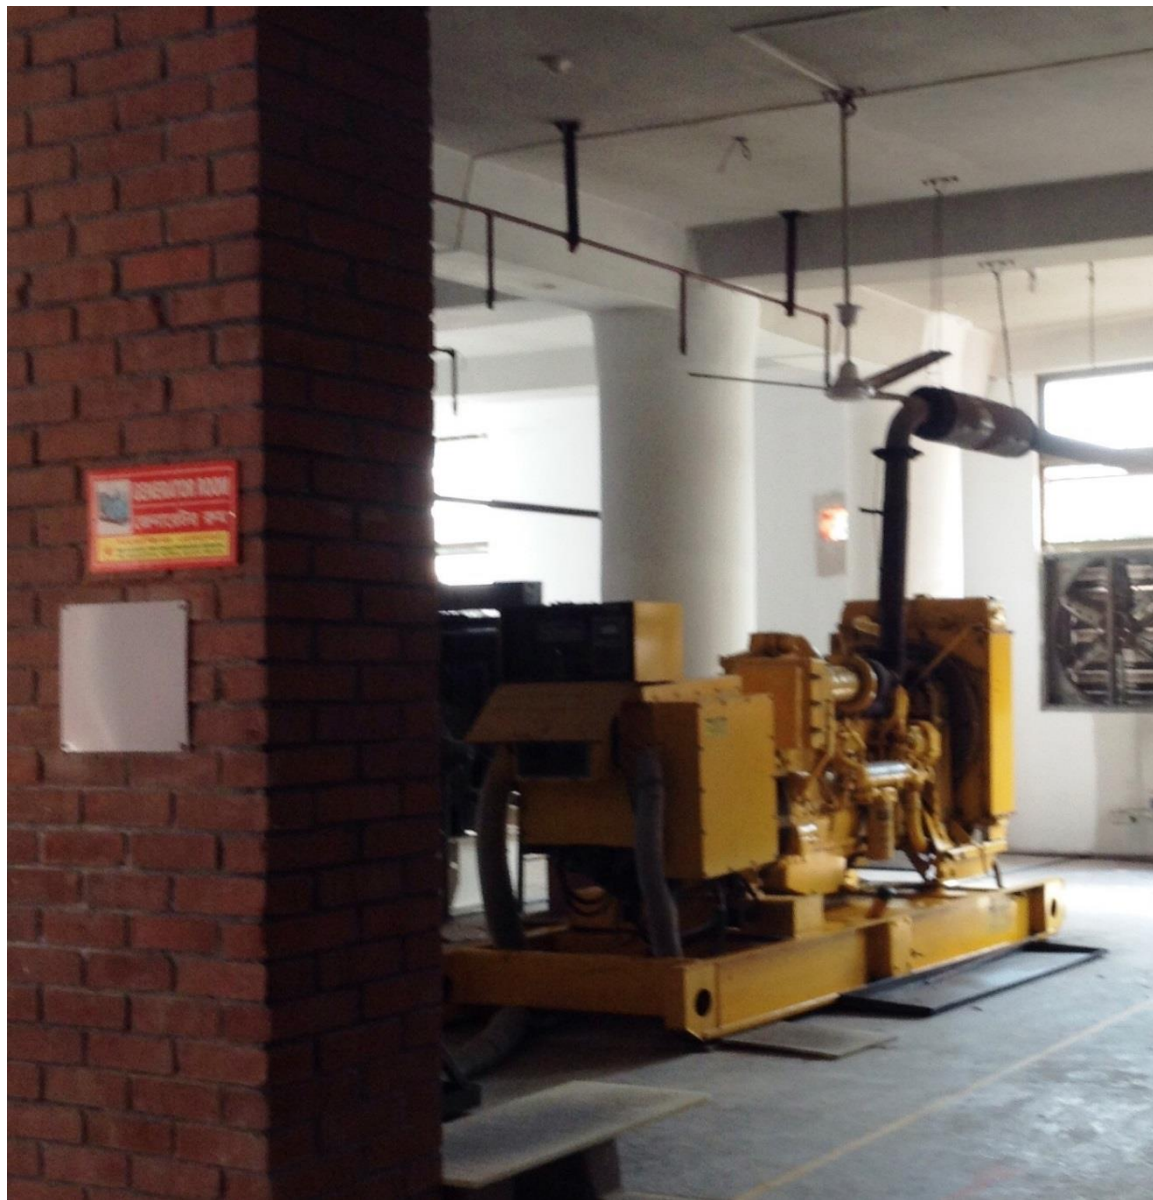
Missing Shock Absorptive Measures on Generator Room

Missing Vibration Absorbers on Generator Room

ITEM 1: Missing vibration absorbers below generators.

Item No.	Observation	Recommended Action Plan	Recommended Timeline
1	Missing vibration absorbers in generator room.	Building Engineer to review generator room slab and consult with generator manufacturers necessary vibration absorber devices.	6-weeks
