MTM GARMENTS LTD.

15934/16004 Chandpara, Medical Road, Uttarkhan
(23.877554N,90.434111E)

4th November 2015

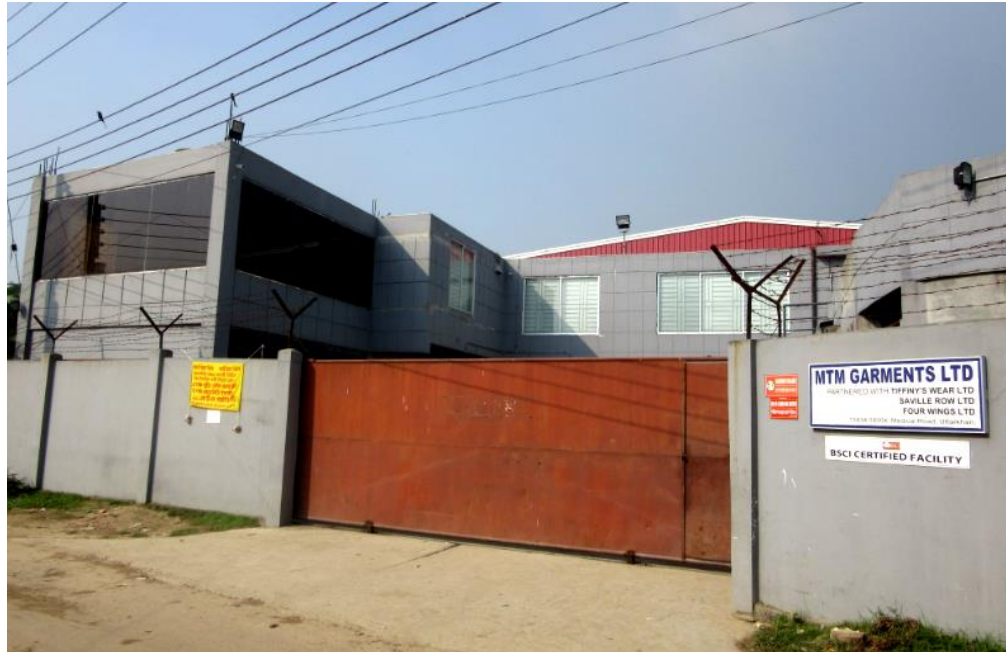
Lack of vertical bracing

Item No.	Observation	Recommended Action Plan	Recommended Timeline
1	Lack of vertical bracing	Building Engineer to check lateral stability of the buildings	6-weeks
2	Lack of vertical bracing	Missing vertical bracing should be completed	6-weeks
3	Lack of vertical bracing	Make structural alterations if required as advised by Engineer	6-months
4	Poorly constructed / installed hangers	Remove all suspensions to the bracings and do a proper connection to the main / secondary structural elements	6-months
5	Poorly constructed / installed hangers	Repair burnouts in the purlins	6-months
6	Cracking in walls	Repair the cracks	6-months

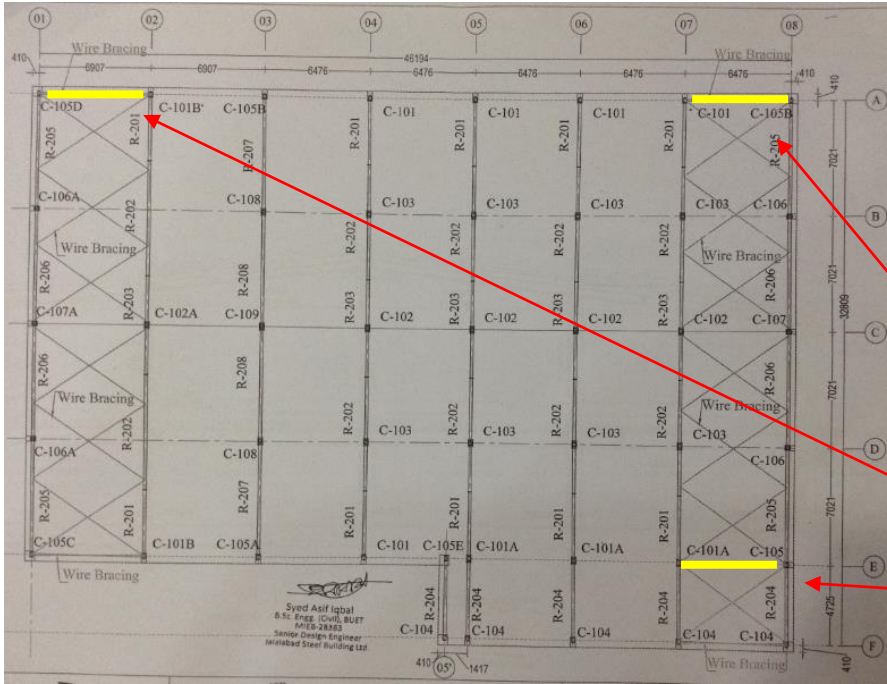
Lack of vertical bracing

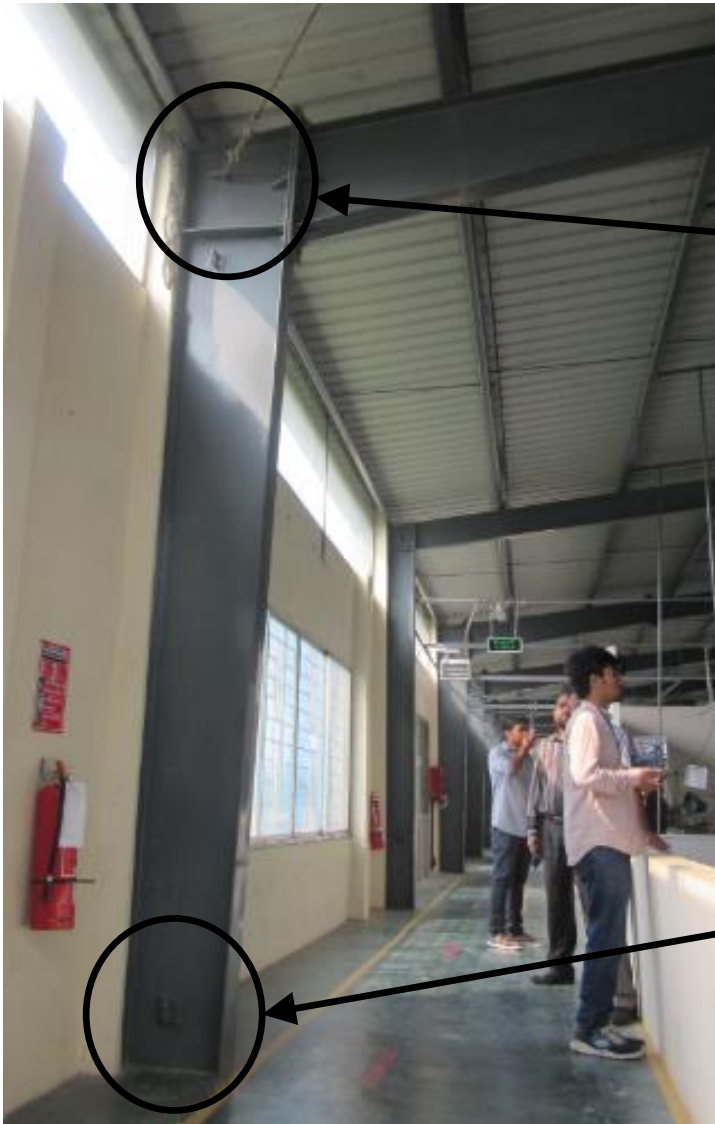
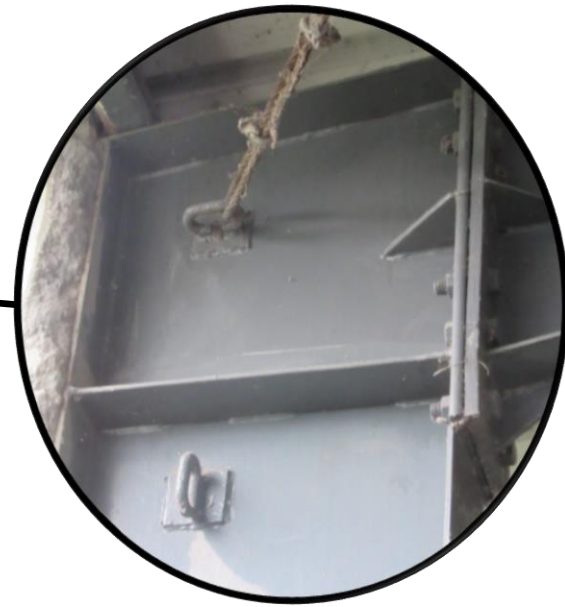
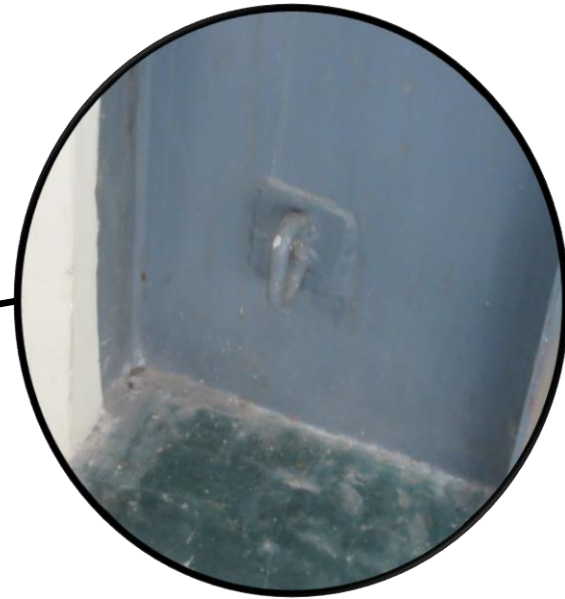
Connections for bracing unused

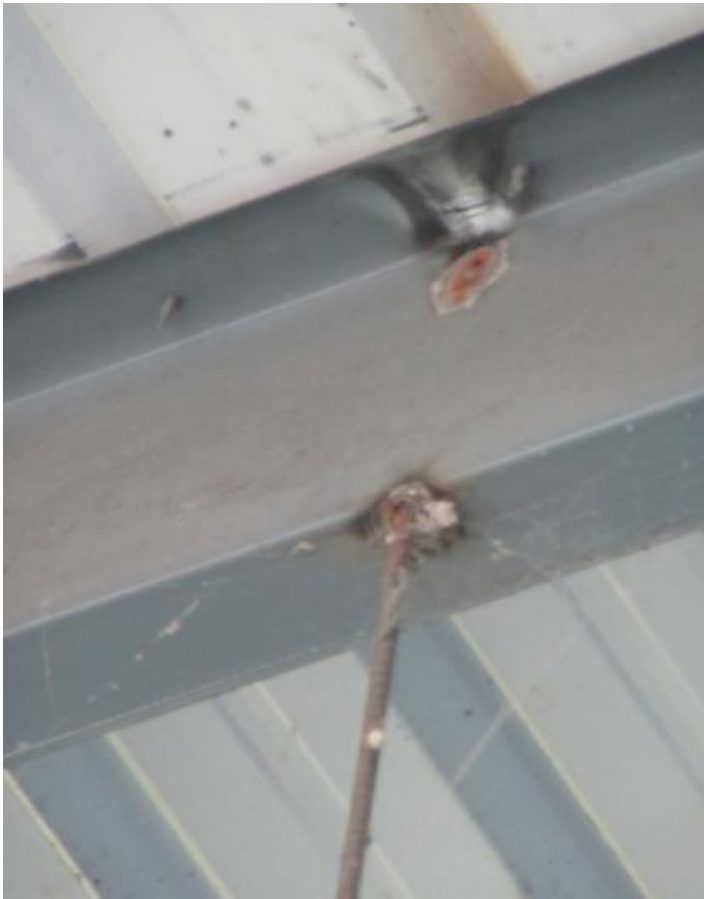
Holes drilled into purlins and hangers welded on

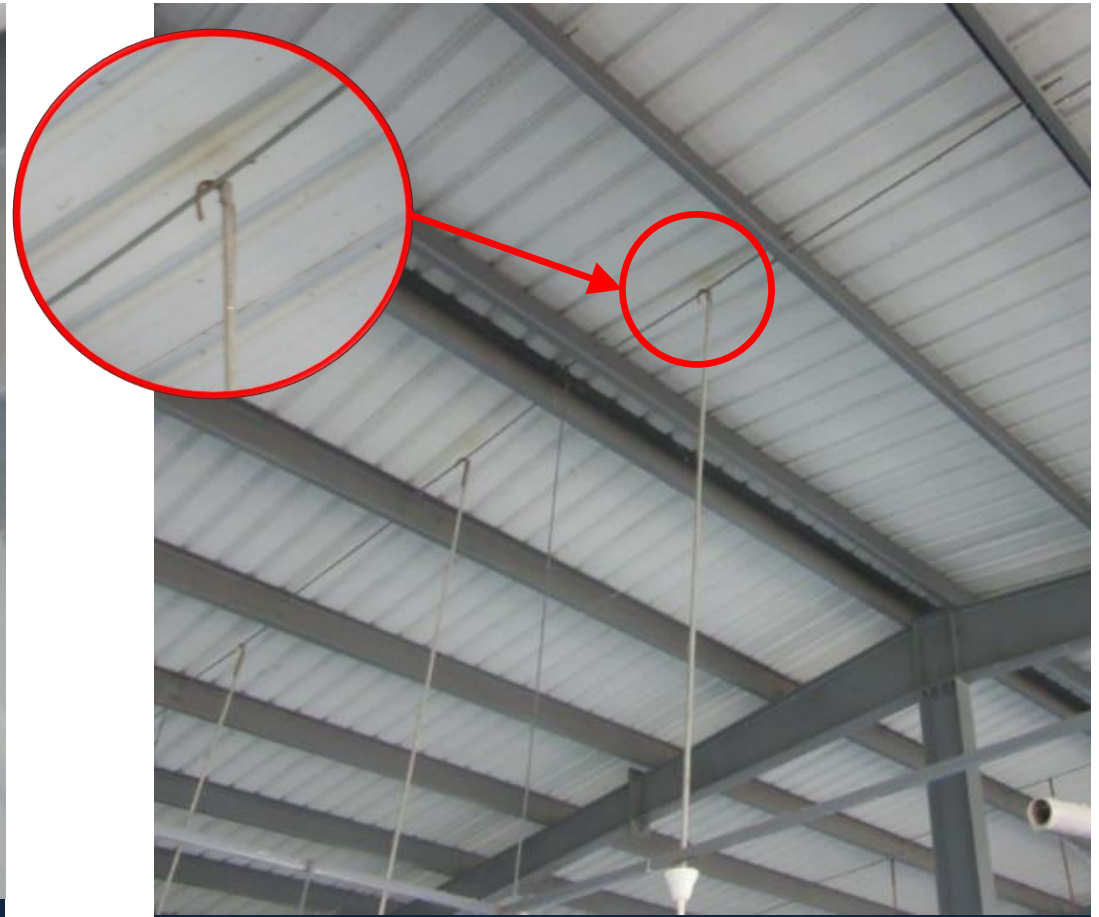
Hangers hooked on purlin lateral restraints

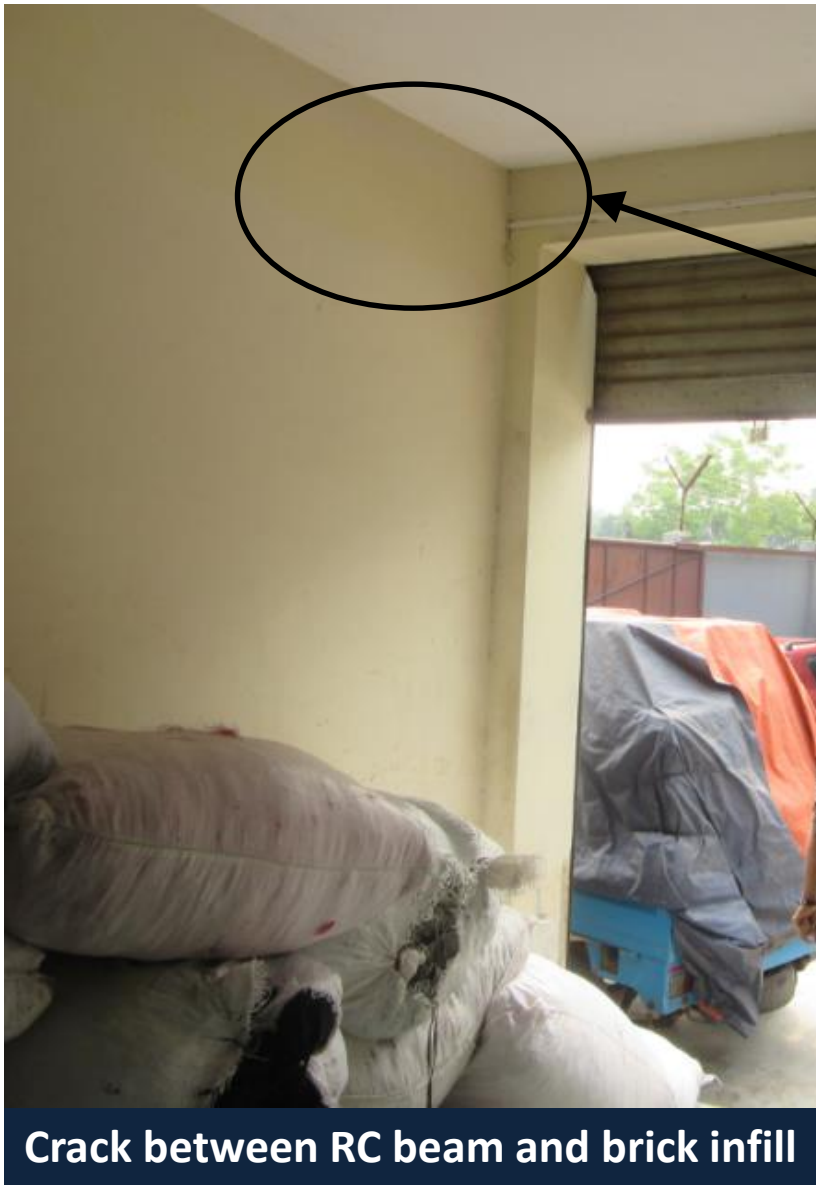
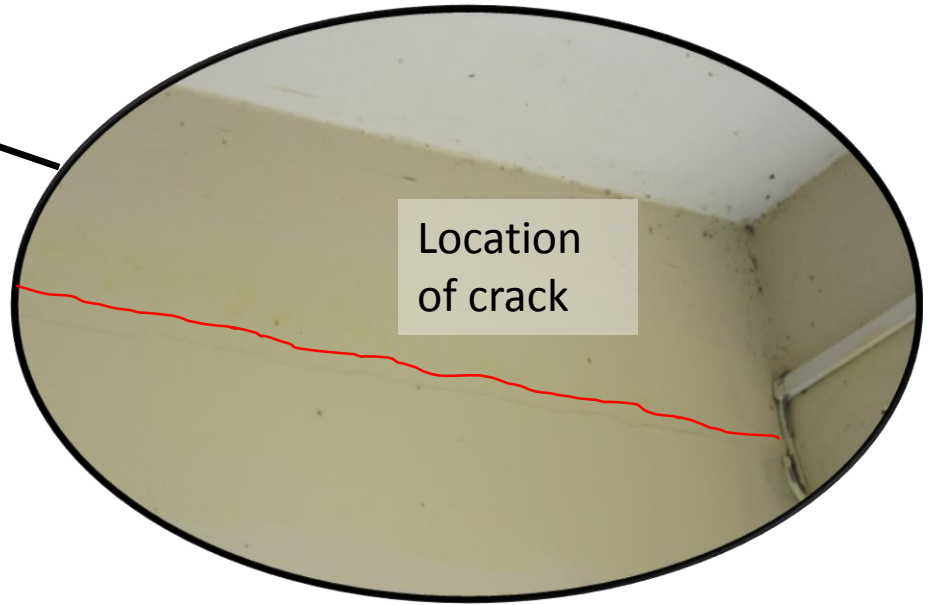
Cracking in walls

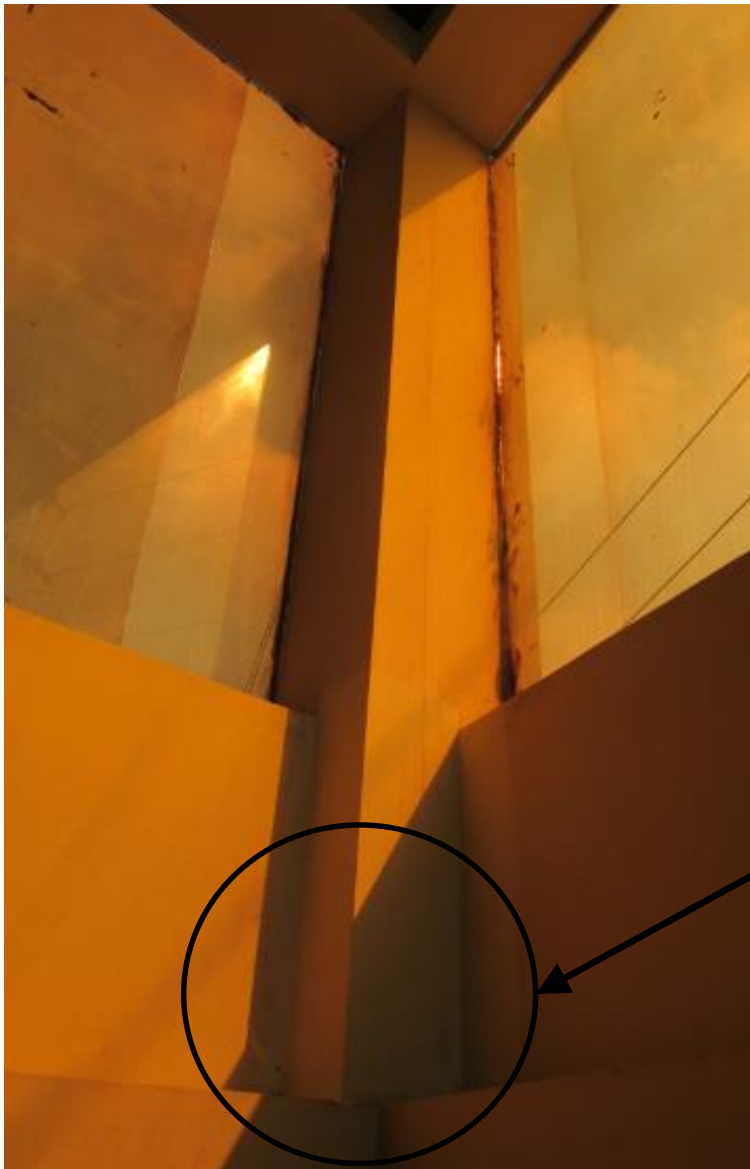
Crack recently painted over

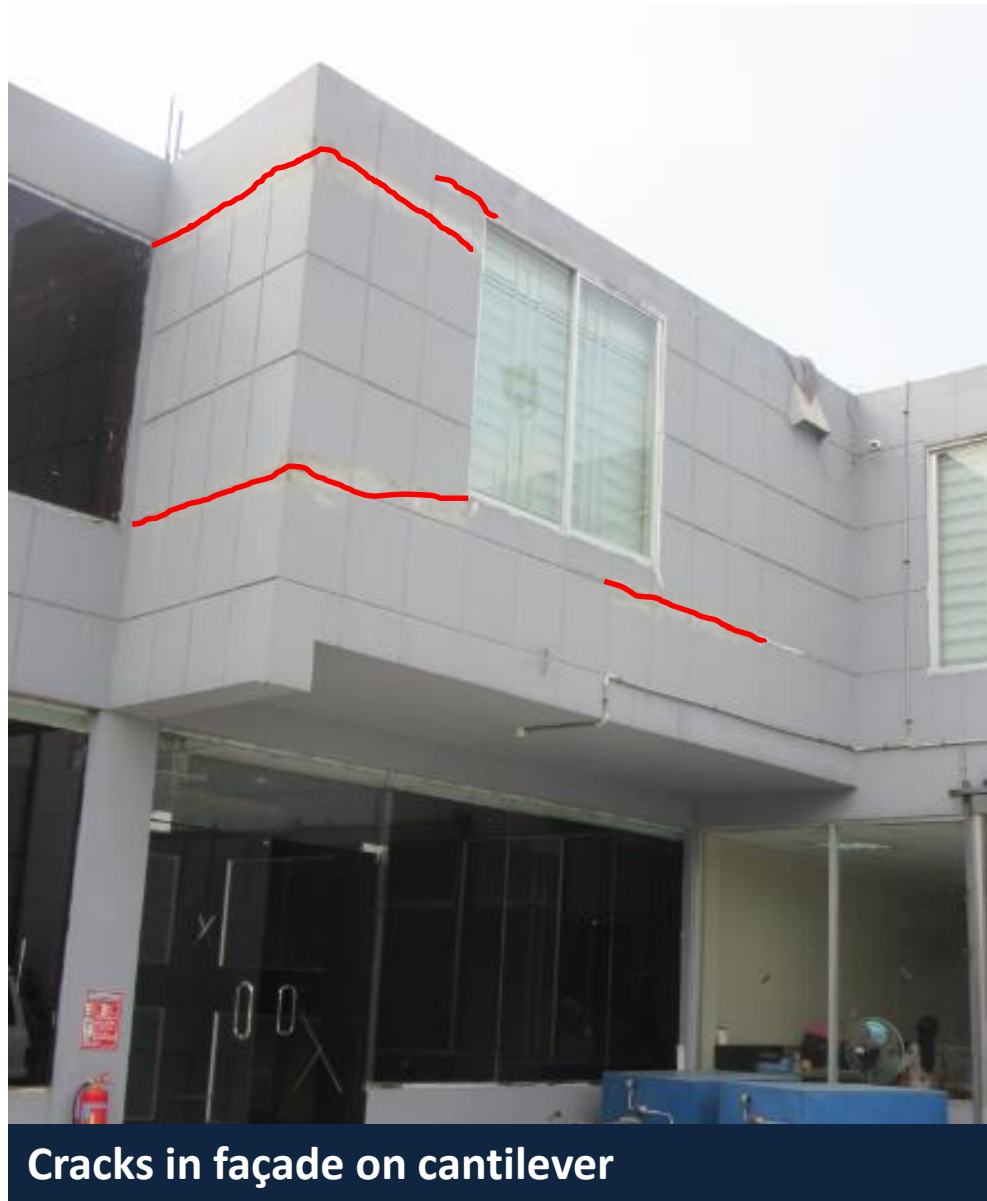
Cracks in façade on cantilever
