# INITIAL STRUCTURAL INTEGRITY ASSESSMENT REPORT (SIAR)

Factory Name: **SIMBA FASHION LTD Extension plot**  
Address: **Plot # 259,260,277,278 Adamjee EPZ, Siddirgonj,  
Narayangonj Siddirgonj Dhaka Bangladesh**  
Assessor: **BD Technologies**  
Date: **17 Jan 2016**

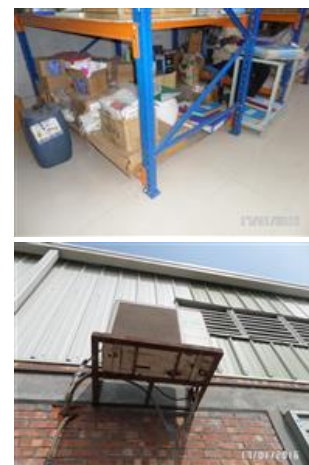
Question:	Are all non-structural elements suspended from, attached to, or resting atop the structure adequately anchored and braced to resist earthquake forces?
Priority Level:	Medium
Non-Compliance Level:	2
Description:	The following non-structural elements required seismic bracing: 1. Storage Rack in Ground Floor; 2. AC outdoor unit.
Source of Findings:	Visual Assessment: Visual Assessment on Site visit January 17, 2016.
Suggested Plan of Action:	Adequately anchor and brace all non-structural elements to resist earthquake forces to comply with the BNBC and Alliance Standard.
Suggested Deadline Date:	31 Mar 2016
Standard:	Alliance Standards Part 8 Section 8.18 Seismic Bracing of Key Non-Structural Elements and 2006 BNBC Part 6
