# ABSS High Tech Sweater Ltd.

Kalameshar, Board Bazar, Gazipur

10 May, 2016

## Client Summary Report

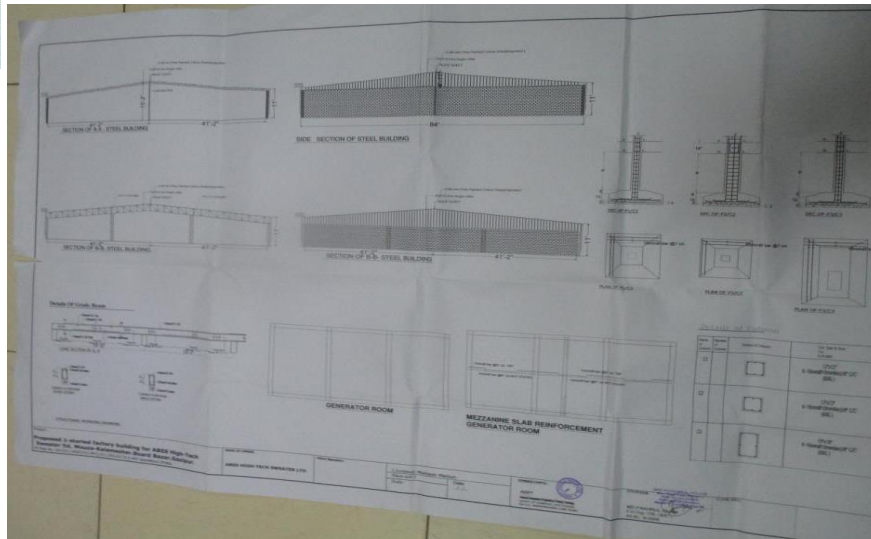
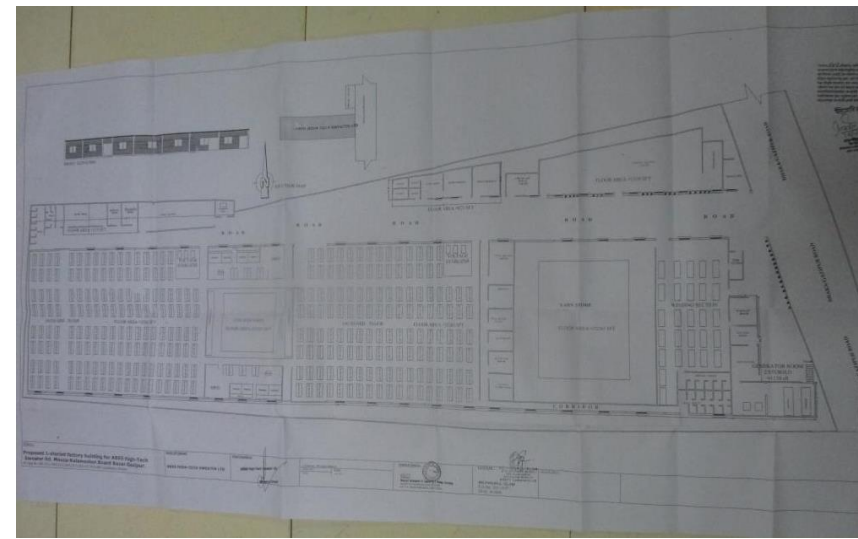
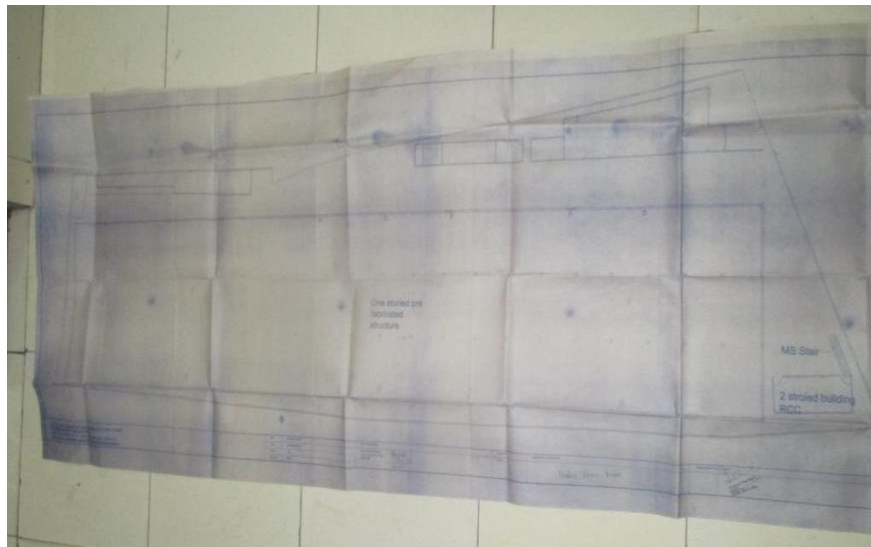
# Improper documentation

Factory showed us sets of permit drawings from local authority and Industrial inspection Authority of Bangladesh. These drawings only shows layout plan for whole compound but structural drawing not shown. A full set of as-built drawing to be prepared showing detail arrangement of structural members.

- Building engineer to check, collect information and produce accurate and complete as-built documentation.

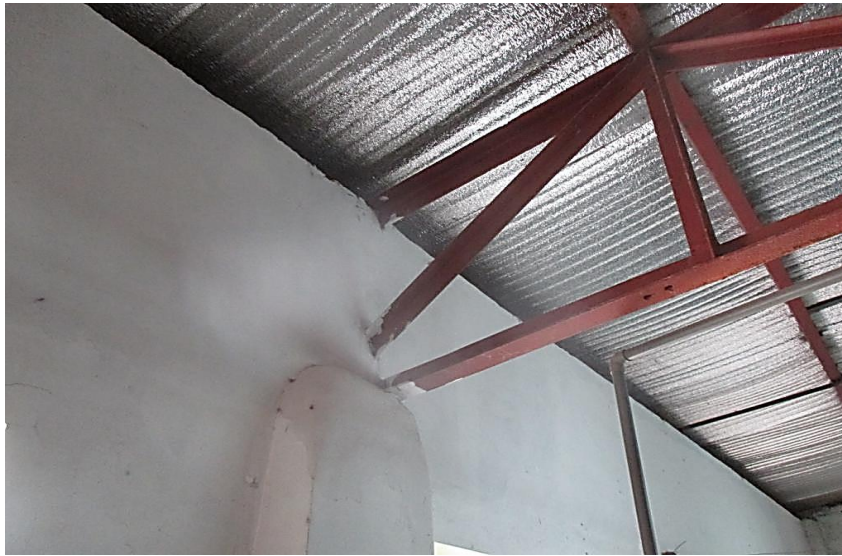
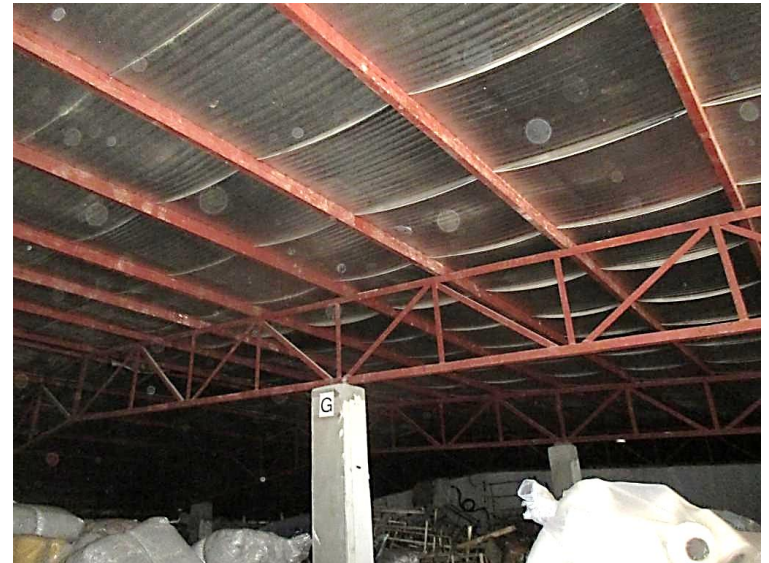
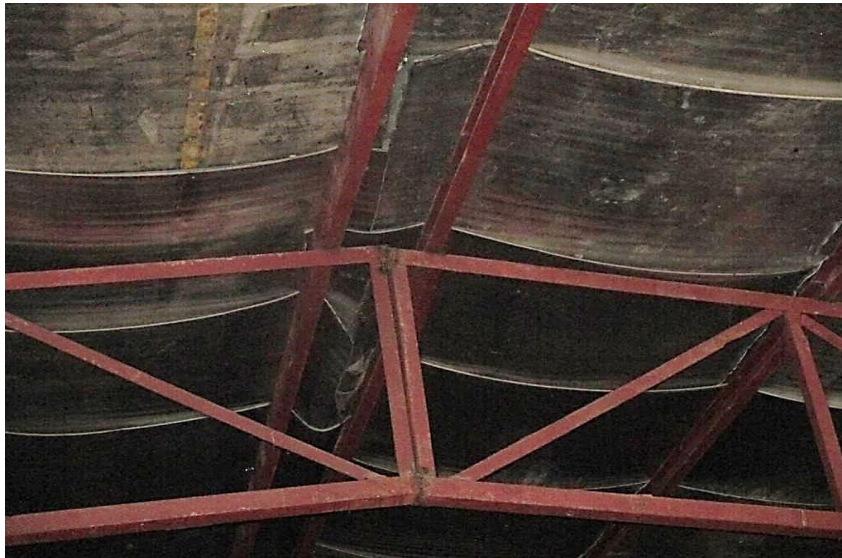
# Stability check for Non-engineered steel roof against lateral load

Steel shed appears to be non-engineered (no apparent lateral stability system, apparently non engineered connections)

- The Building Engineer shall provide calculations showing the structural adequacy of non-engineered steel shed against lateral force

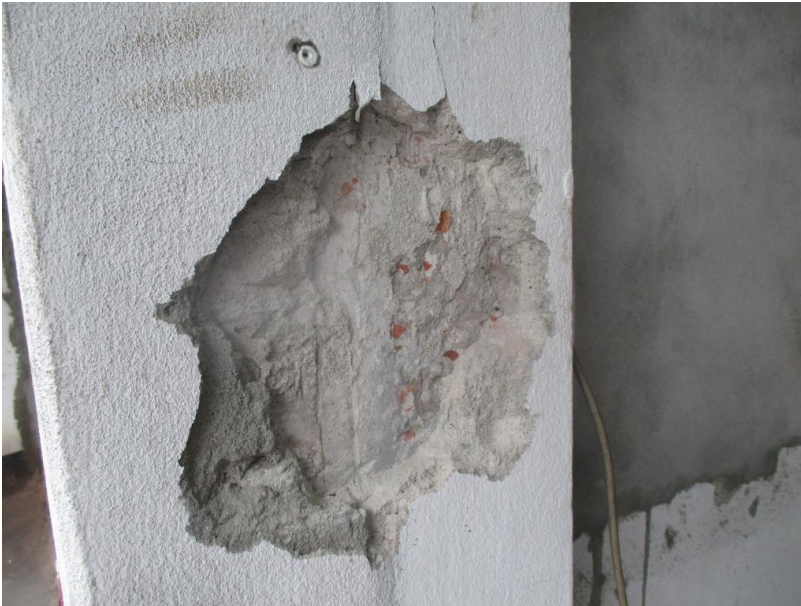
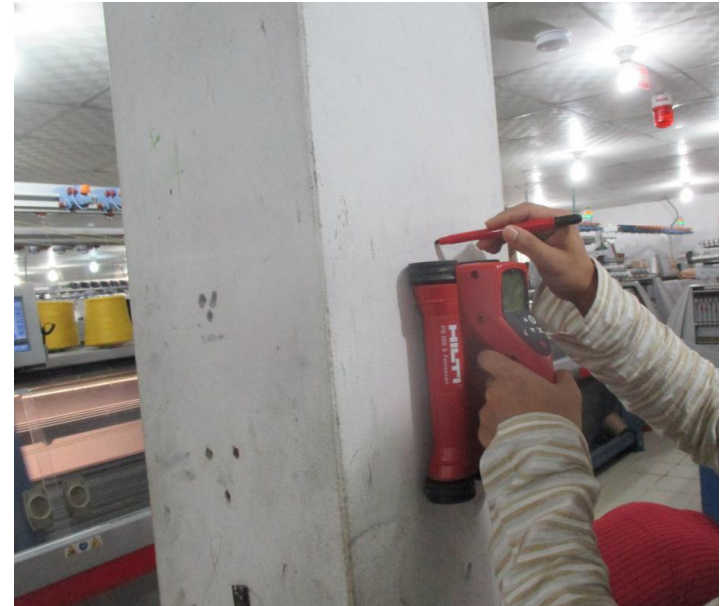
# Test Carried out

**Aggregate type and rebar checking**
