# INITIAL STRUCTURAL INTEGRITY ASSESSMENT REPORT (SIAR)

Factory Name: **SHADE FASHIONS INT'L LTD**

Assessor: **Emkay Enterprises LTD**

Date: **24 Apr 2014**

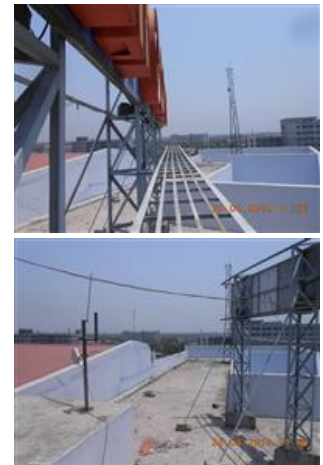
Question:	Have provisions been made in floors or decks for a concentrated load (such as heavy equipment, water tanks, stored materials, etc) applied at a location wherever this load acting upon an otherwise unloaded floor would produce stresses greater than those caused by a uniform load?
-----------	---

Description:	Roof top RCC water tank of size 10'X18.5'X6.5', which has no structural drawings and no structural analytical evaluation available. A steel Billboard is placed on the roof top, which has no analytical structural and analytical documents.
--------------	---

Source of Findings:	Document Review: Drawings of Roof top RCC water tank not found. , Photograph: Water tank on roof Billboard structure
---------------------	---
