INITIAL FIRE ASSESSMENT REPORT (FAR)

Factory Name: **SHADE FASHIONS INT'L LTD**

Assessor: **Emkay Enterprises LTD**

Date: **24 Apr 2014**

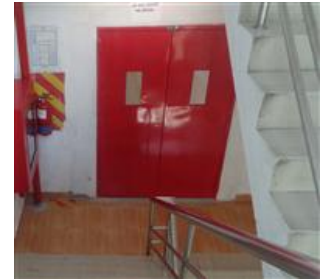
Question:	Occupant loads are posted for every assembly and production floor in a conspicuous space near the main point of egress.
Priority Level:	Medium
Non-Compliance Level:	2
Description:	Occupant loads were not posted for any assembly and production floor in a conspicuous space near the main point of egress.
Source of Findings:	Visual Assessment: No signage was found during inspection.
Suggested Plan of Action:
