Aboni Knitwears Ltd

Tatulzhora-Rishipara road, Savar, Dhaka
(+23.7930,+90.2603)

25 September 2013

**Check on Column stress levels immediately
required**

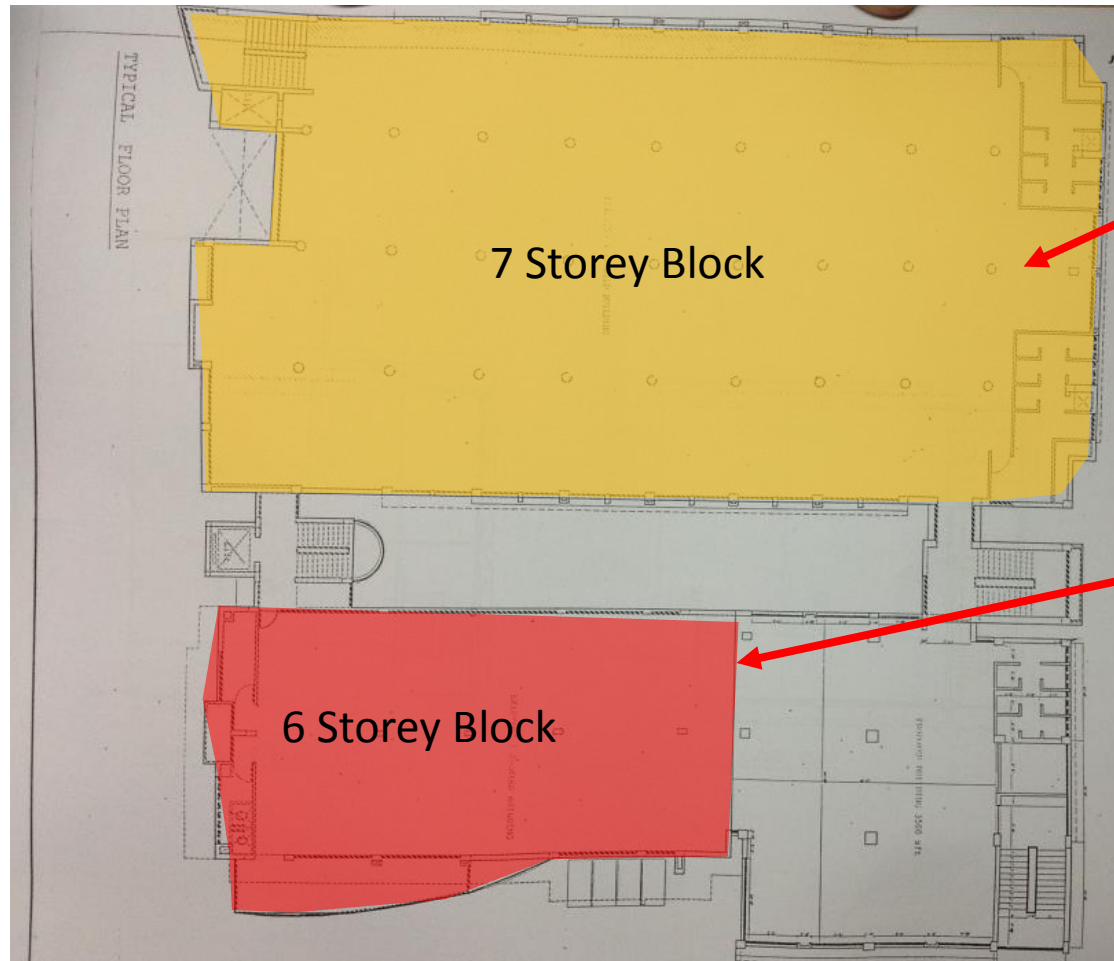
Item 1 High Stress to Building internal columns

Verify concrete strengths in internal columns and reduce loads

No storage in this area on any level, limit all live load to a maximum of 2.0kN/m^2 , on any floor, immediately

Remove all personnel from this building until results of columns strengths and Building Engineering assessment is complete

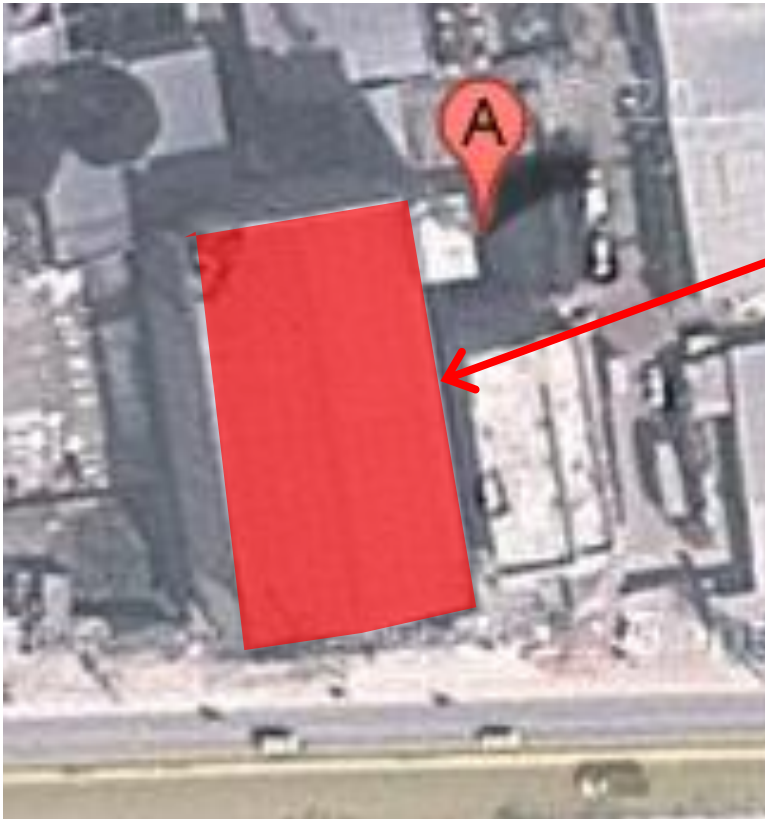
Check on roof additions required

Non-engineered lightweight steel roof additions does not appear to be strong enough for severe wind events or access loading

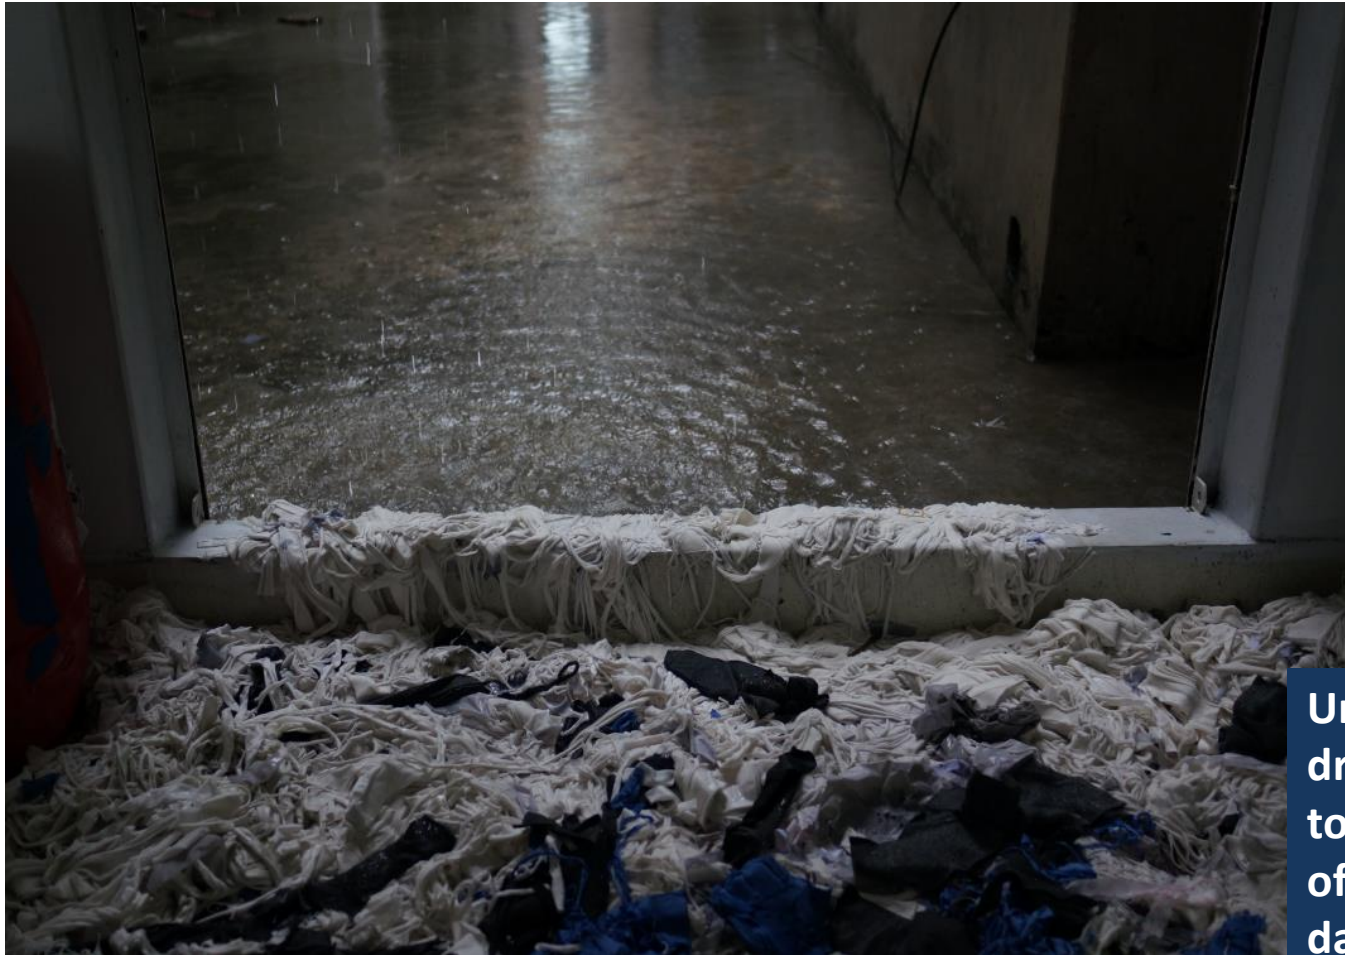
Water causing damage and corrosion

Unmanaged roof drainage causing damage to building. At the time of the survey, structural damage was not observed, but is likely to occur over time

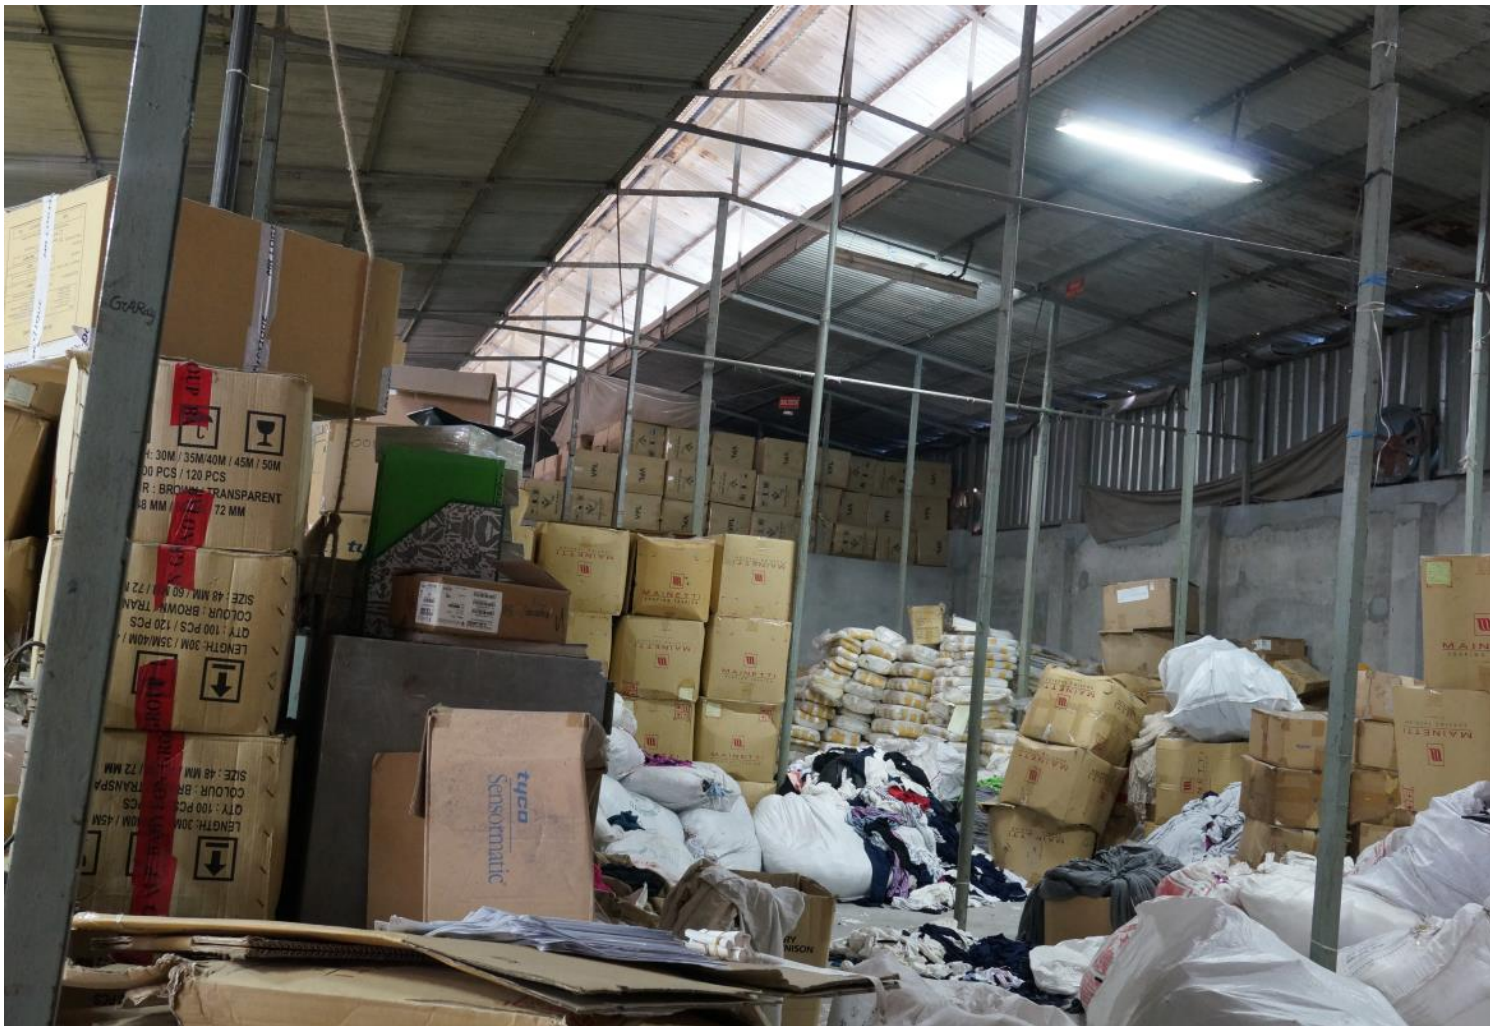
Non-Engineered Steel Structure

Large, non-engineered steel roof structure is unlikely to be able to withstand strong wind events.

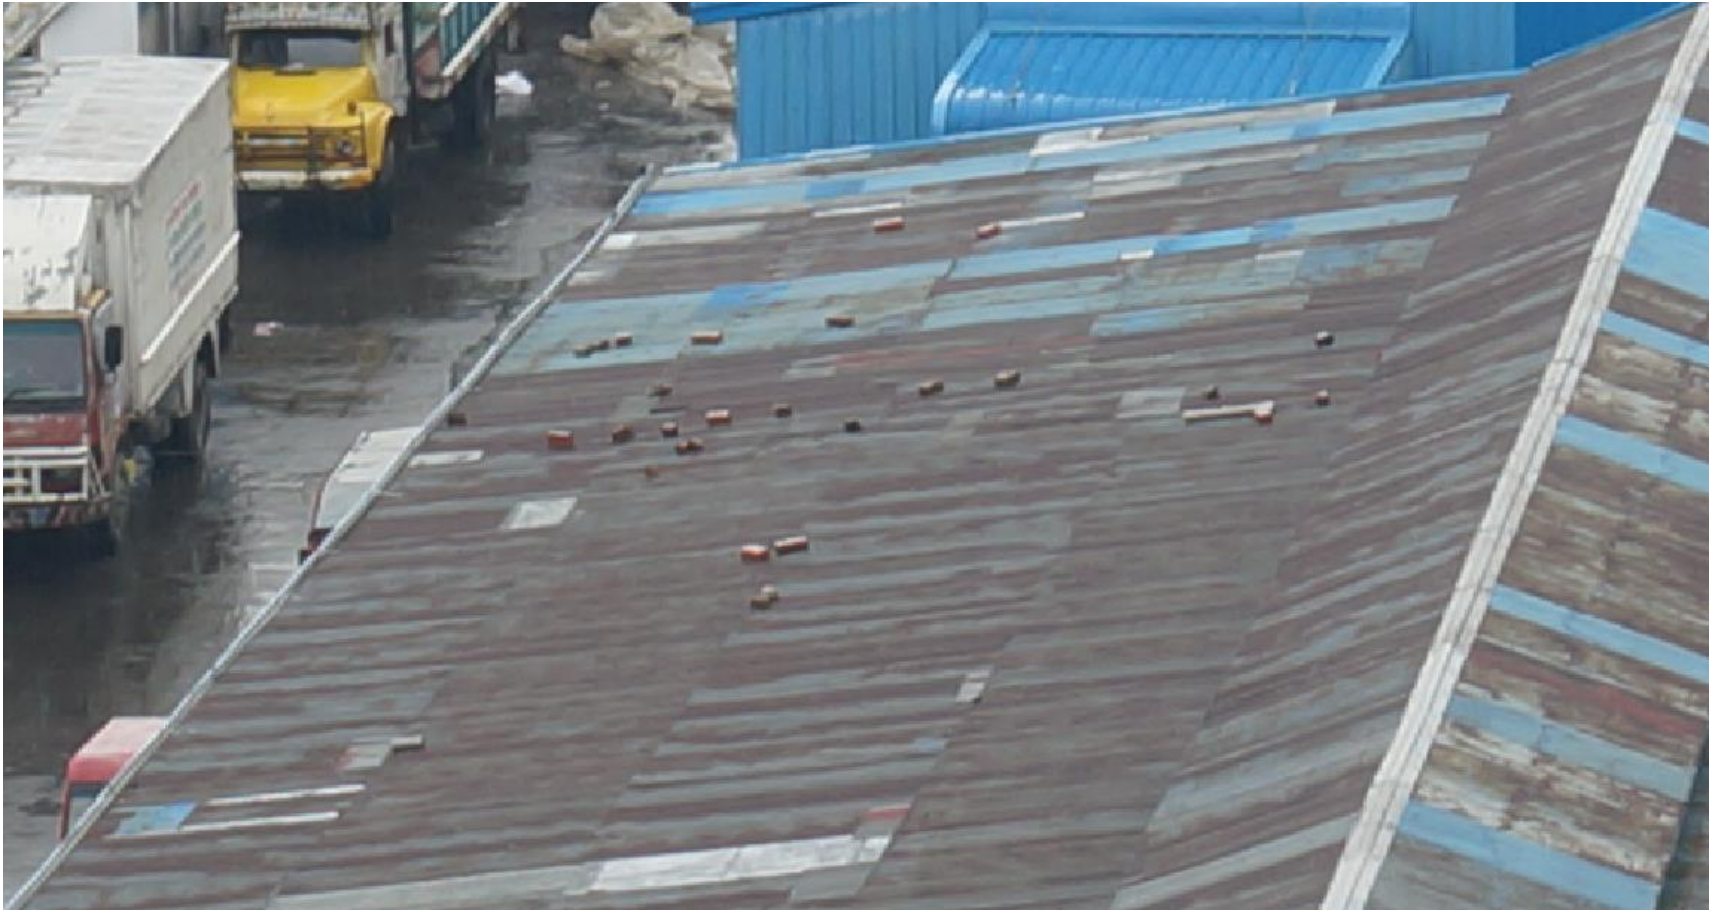
Bricks laid on roof top, perhaps indicating previous wind uplift damage

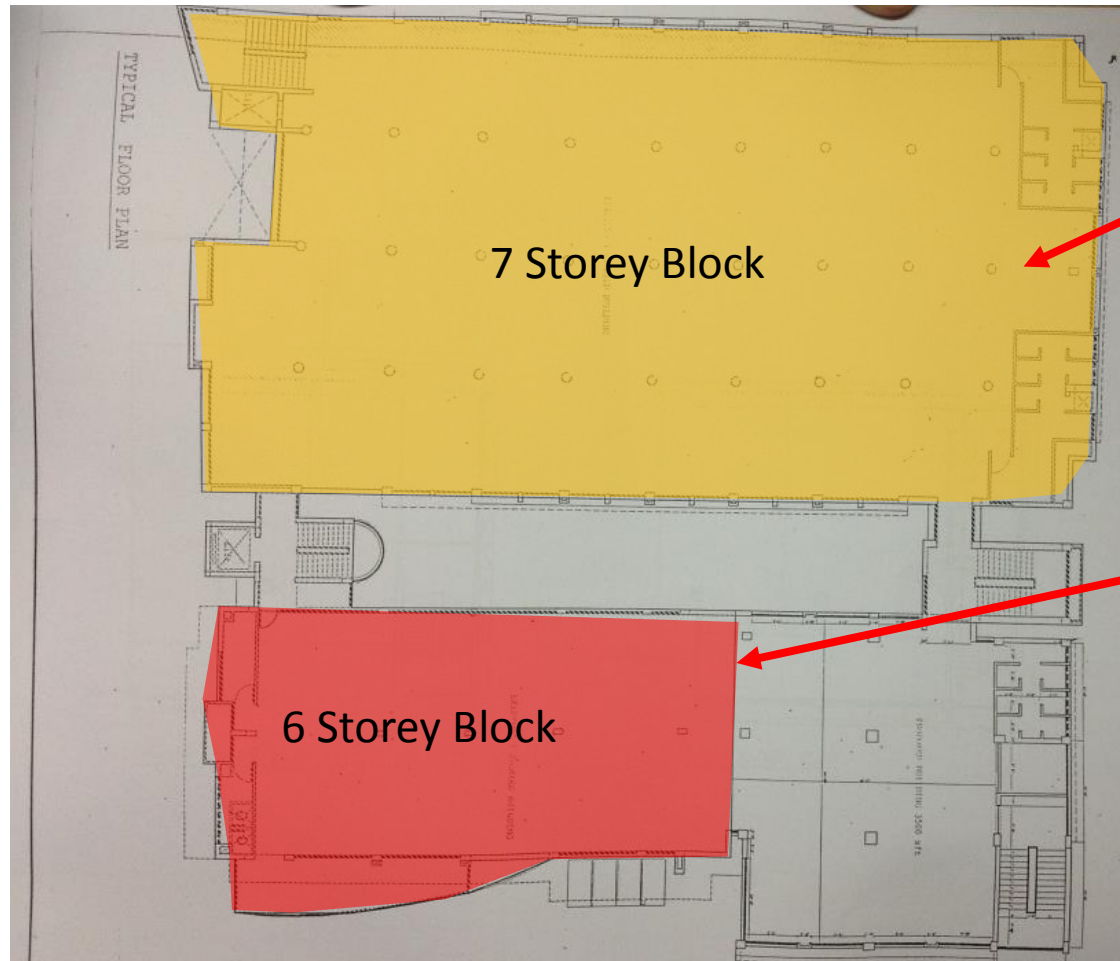
Item 1 High Stress to Building internal columns

Verify concrete strengths in internal columns and reduce loads

No storage in this area on any level, limit all live load to a maximum of 2.0kN/m^2 , on any floor, immediately

Remove all personnel from this building until results of columns strengths and Building Engineering assessment is complete
